TO: Board of County Commissioners
DEPARTMENT: Public Works
PRESENTED BY: Sonny Chickering, County Engineer
AGENDA ITEM TITLE: IN THE MATTER OF CONFIRMING A TEMPORARY CLOSURE OF THE COYOTE CREEK COVERED BRIDGE (STATE BRIDGE ID 39C409) LOCATED AT M.P. 0.1 ON BATTLE CREEK ROAD.

Coyote Covered Bridge Inspection and Evaluation

PREPARED FOR: Lane County, Oregon
 PREPARED BY: Kelly B. Freeman
 DATE: October 18, 2006

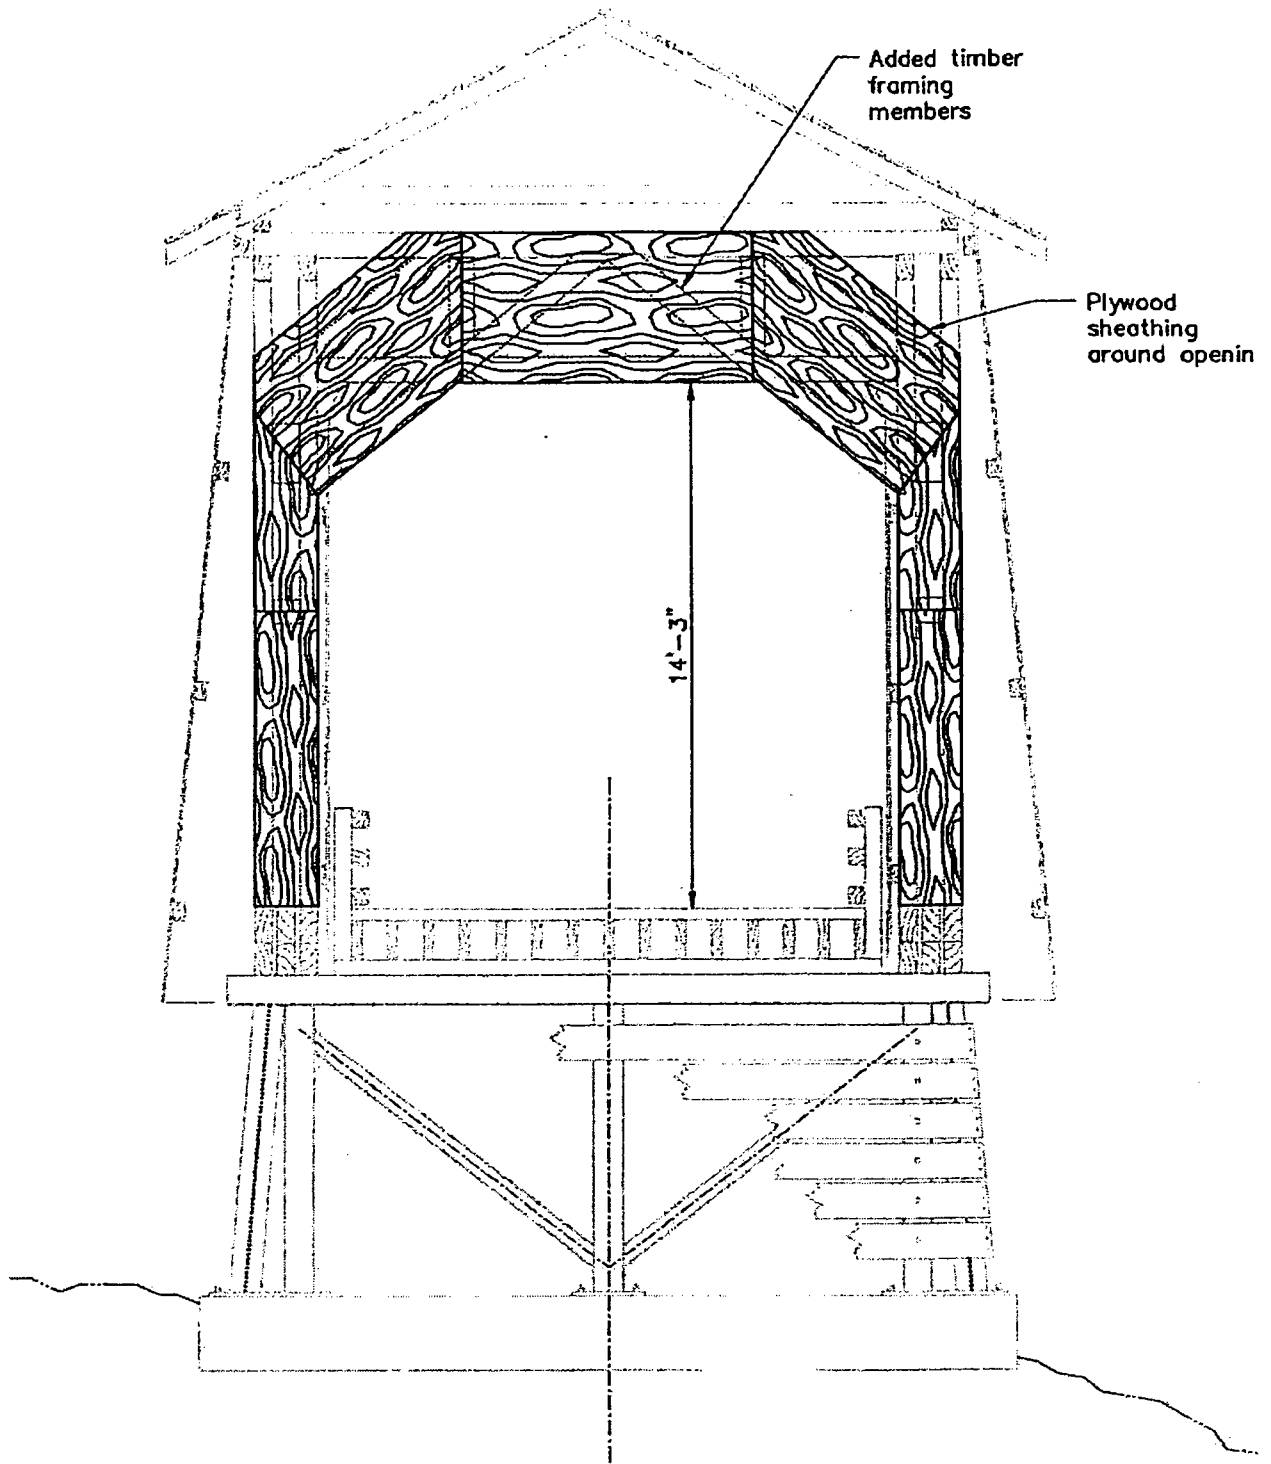
INSIDE VIEW OF END PORTAL
CONCEPT SKETCH OF TEMPORARY STRENGTHENING

The calculated lateral strength of the portal framing alone is quite small due to the comparative weakness of the spiked connection between the knee braces and the header beam, and is dependent on the unknown size and penetration of the spikes. If two 50d to 60d spikes with 4 inches of penetration are assumed at the upper and lower ends of each knee brace, the lateral allowable capacity of the portal would be calculated at approximately 800 to 1000 pounds. This lateral capacity is roughly the magnitude of the lateral force effect caused by the racking from the combined gravity load effects of self weight, snow loads and an H10 live load, but is a fraction of the wind forces (calculated according to the 2003 IBC) at 4,400 pounds per portal. Under normal conditions, therefore, the portal framing alone does not have adequate capacity for lateral forces due to wind loads.

Due to the unknown, uncertain or inadequate lateral capacity of each of the contributing systems to the overall lateral resistance and stability of the structure, the safety of the bridge in use is also not verifiable and the bridge should remain closed until the bridge is repaired or a temporary strengthening of the bridge should be constructed before re-opening the bridge to traffic.

The consultant recommended one means of temporarily strengthening the bridge end portals until permanent repairs are made would be to add timber framing and sheath the inside faces of the portals with plywood, thereby creating a shear wall system around the traffic openings, at each bridge end. These repairs are to help resist lateral loads, such as wind, or the horizontal component of applied snow loads, and are not meant to provide a permanent structural solution. Full bridge

One means of temporarily strengthening the bridge end portals until permanent repairs can be made in the summer of 2007 is to sheath the inside faces of the portal with plywood to create a shear wall system around the traffic opening. This will require the addition of several framing members to the end portals to deepen the framed area below the header beam and knee braces, and will require some tie-down brackets at the lower ends of the posts. A concept sketch of the strengthening is attached.

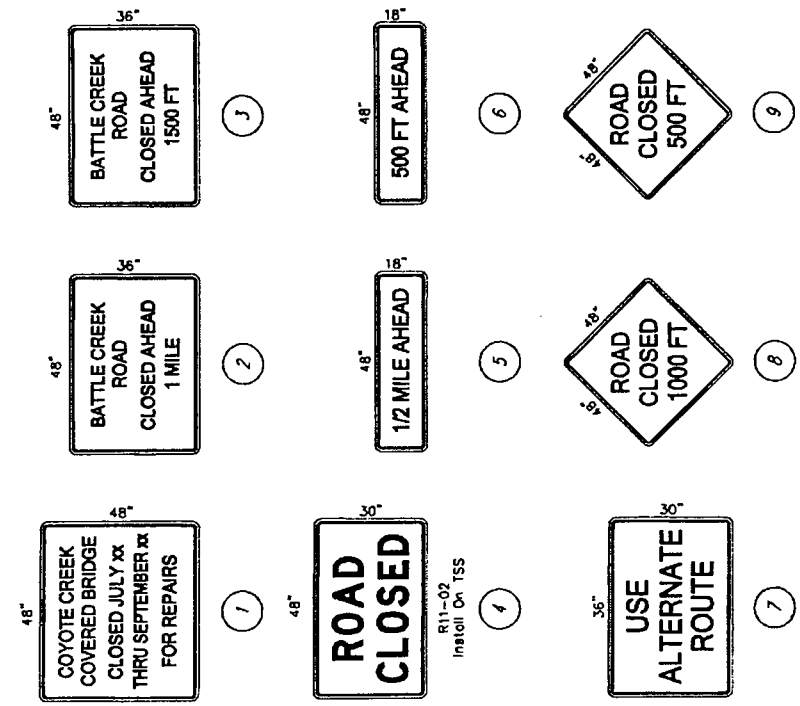
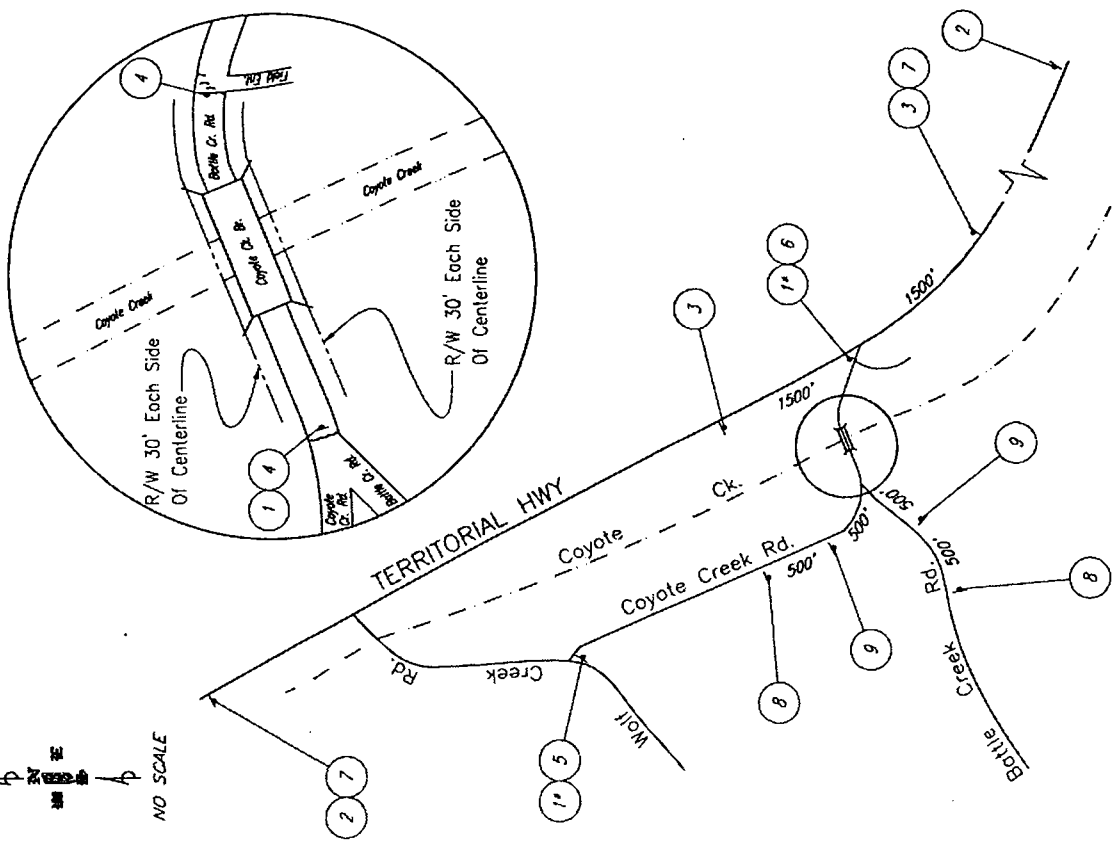
DATE	APR 2006
PROJECT NO.	4082-2
ROAD	4082-2
TEMPORARY PROTECTION & DIRECTION OF TRAFFIC	
COYOTE CREEK COVERED BRIDGE #18-SW-32	
BATTLE CREEK ROAD - M.P. 0.117

The detour mapping for the closure of the bridge is shown on sheet number 3 of the contract construction drawings, attached to this memo. For residents traveling north on Territorial Highway, the bridge closure will require about 1.25 miles of out of direction travel. One concern by some area residents and County staff is high water on Wolf Creek Road and Coyote Creek Road if Coyote Creek runs high this winter. This may happen about three times per year, or never, depending on the amount of winter rain. We recommend that if the water is too high to travel safely on the detour roads, then the bridge be opened up to a posted weight limit of 3 Tons during the high water period, and immediately reclosed. This assumes that the temporary strengthening of the bridge end portals as discussed above provides adequate shear strength against lateral forces. Assessment of this situation will be provided by County staff.
