SHELTER COVE SUBDIVISION - HISTORIC EROSION REPORT

LOWER SIUSLAW ESTUARY

FLORENCE, OREGON

NOVEMBER 2001

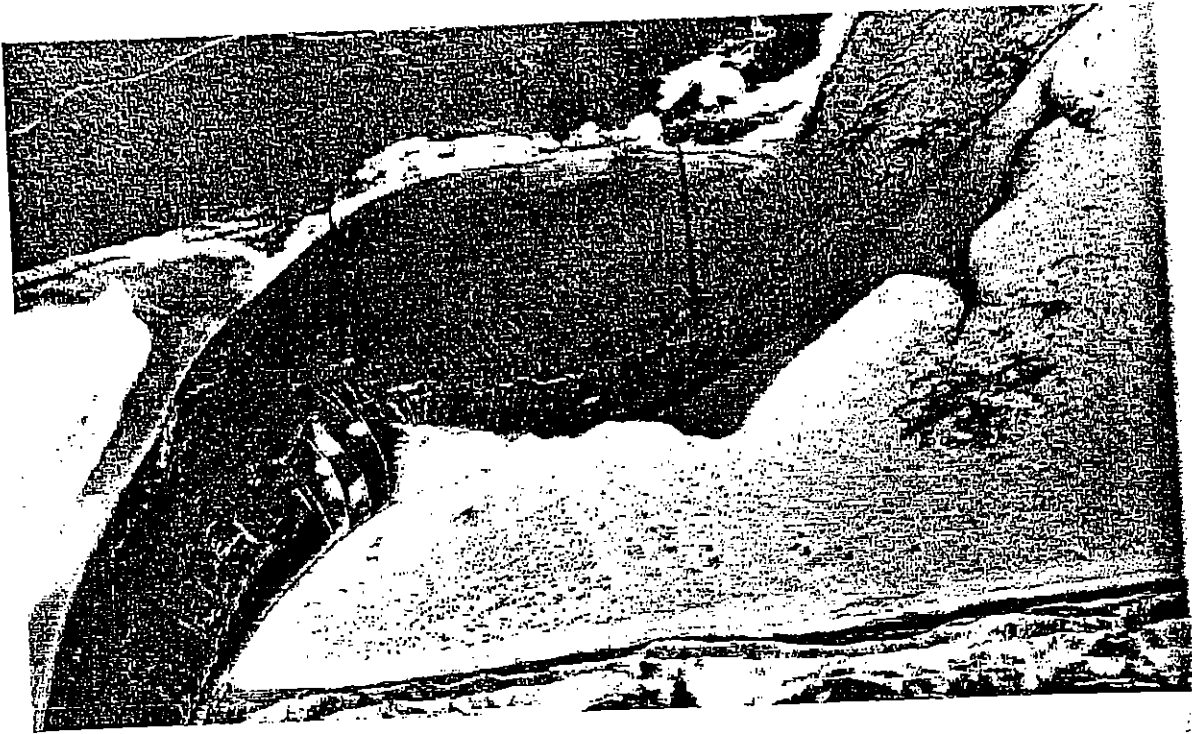
Photo 1. Lower Siuslaw River Estuary in 1939 (U.S. Army Corps of Engineers). Red lines indicate area of eroding bluffs.

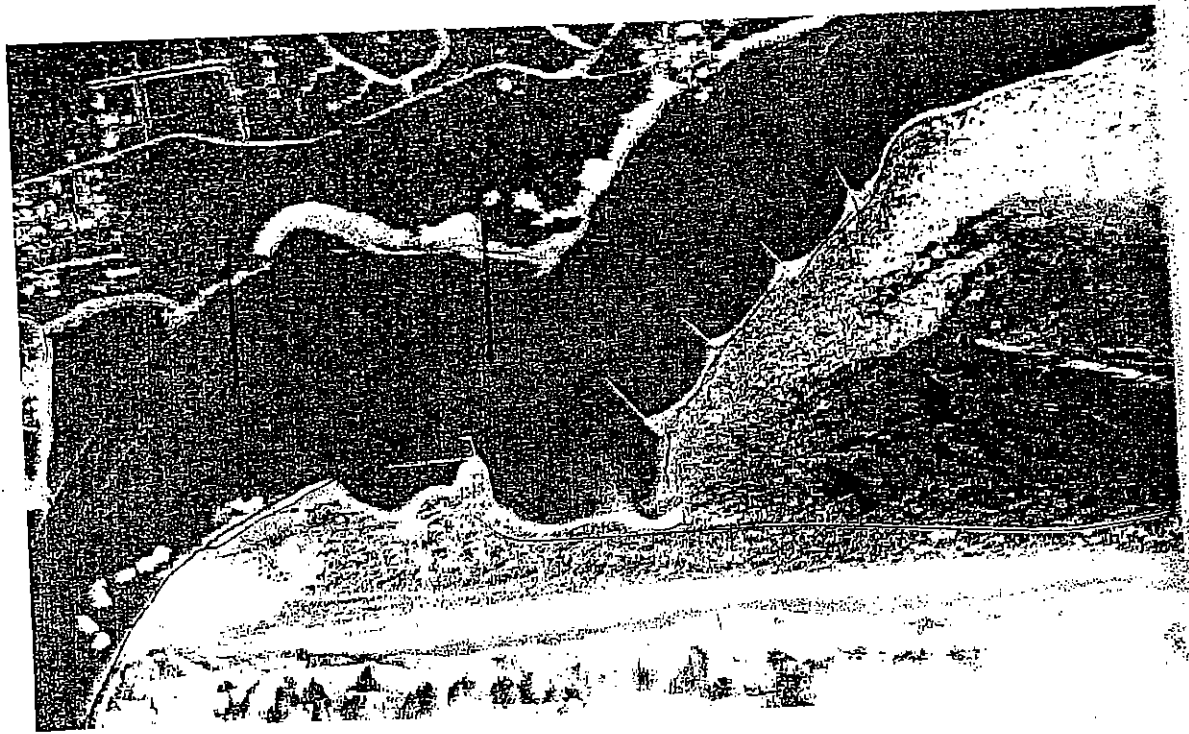
Photo 2. Lower Siuslaw River Estuary mid 1980s (Photo provided by W. Ternyik). Red lines indicate same area of eroding bluffs as shown in Photo 1.

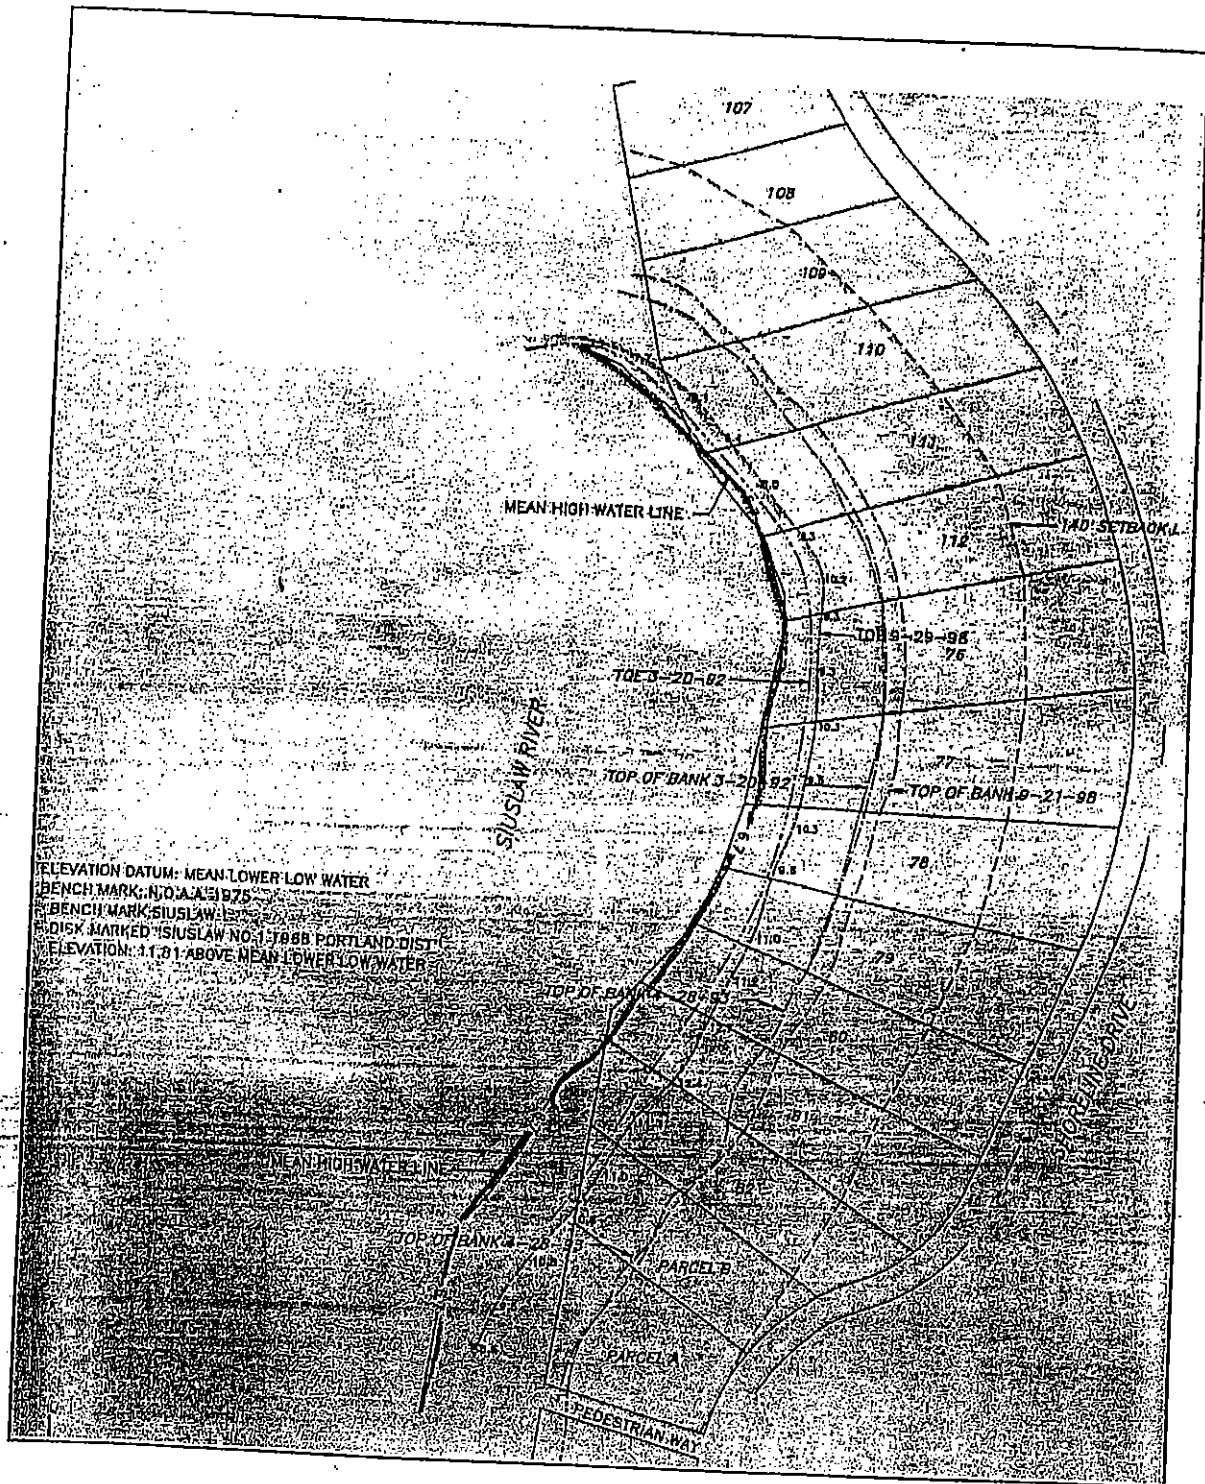
Figure 2. Progression of bank erosion between 1992 and 1998 at Shelter Cove bluff based on surveys conducted in 1992 and 1998 (Schematic diagram provided by Hurst Companies of Oregon).

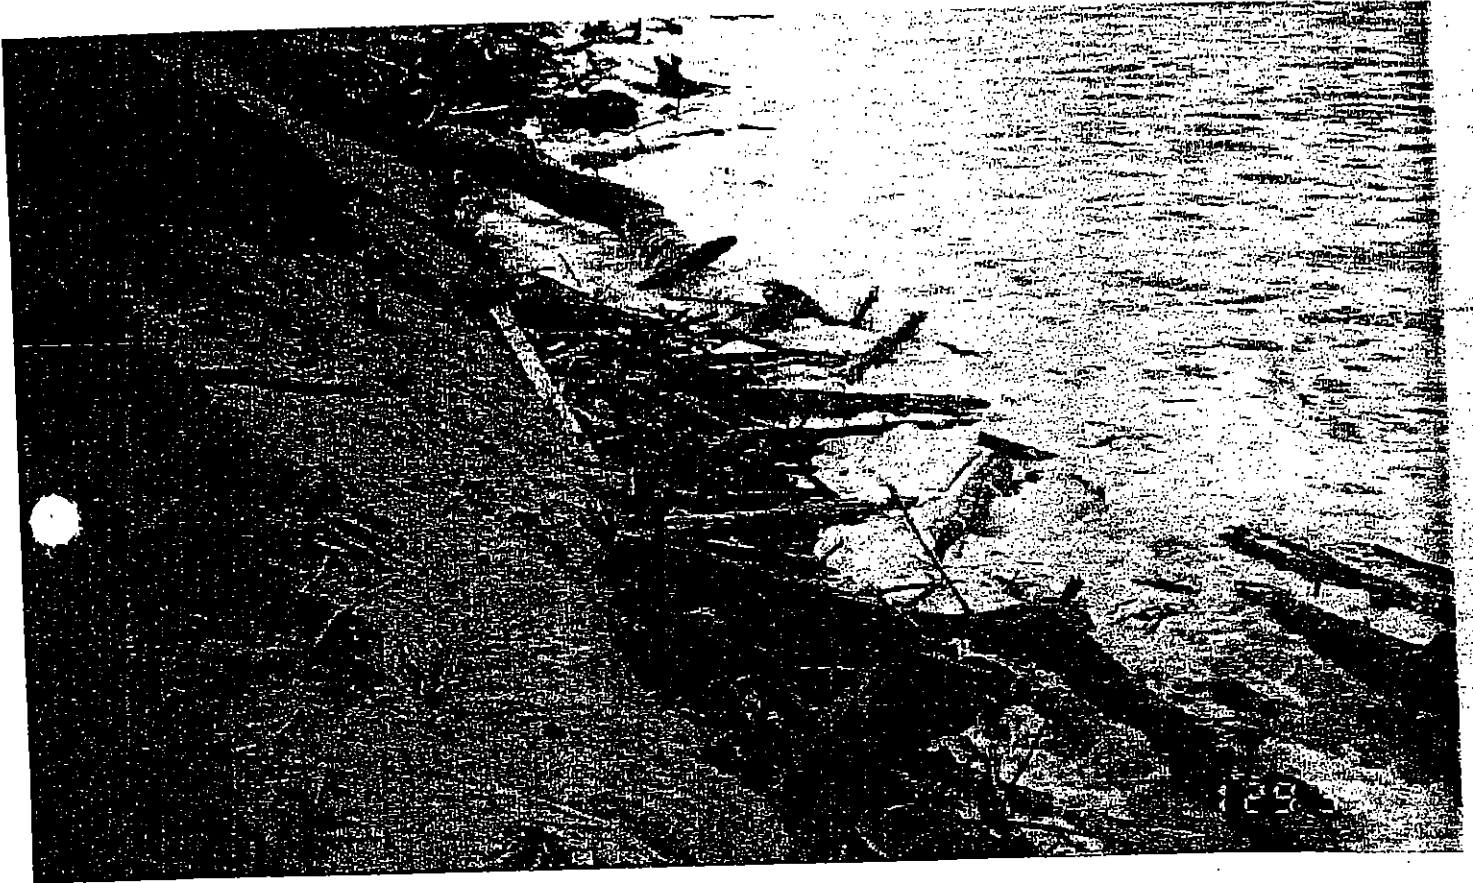
According to the Ogden Beeman & Associates, Inc. report, it is probable that the erosion of the north bank started even when the jetty was in good condition due to wave energy penetration into the estuary through the rubble mound jetty. An U.S. Army Corps of Engineers photo taken in 1939 (Photo 1) shows the inner jetty and the early stages of the bank erosion. As the jetty deteriorated over time, the wave energy was able to pass through the jetty without reduction. An aerial photo from the 1980s (Photo 2) shows the development of the "cusps" in the bank as discussed previously. Figure 2 shows the progression of the erosion on the larger cusp from 1992 through 1998. In the present situation, the waves can attack the toe of the slope directly, particularly at high tide (Photo 3).

Photo 3. Waves and logs washing directly against toe of Shelter Cove sand bluff in December 1999 (Photo provided by W. Ternyik).

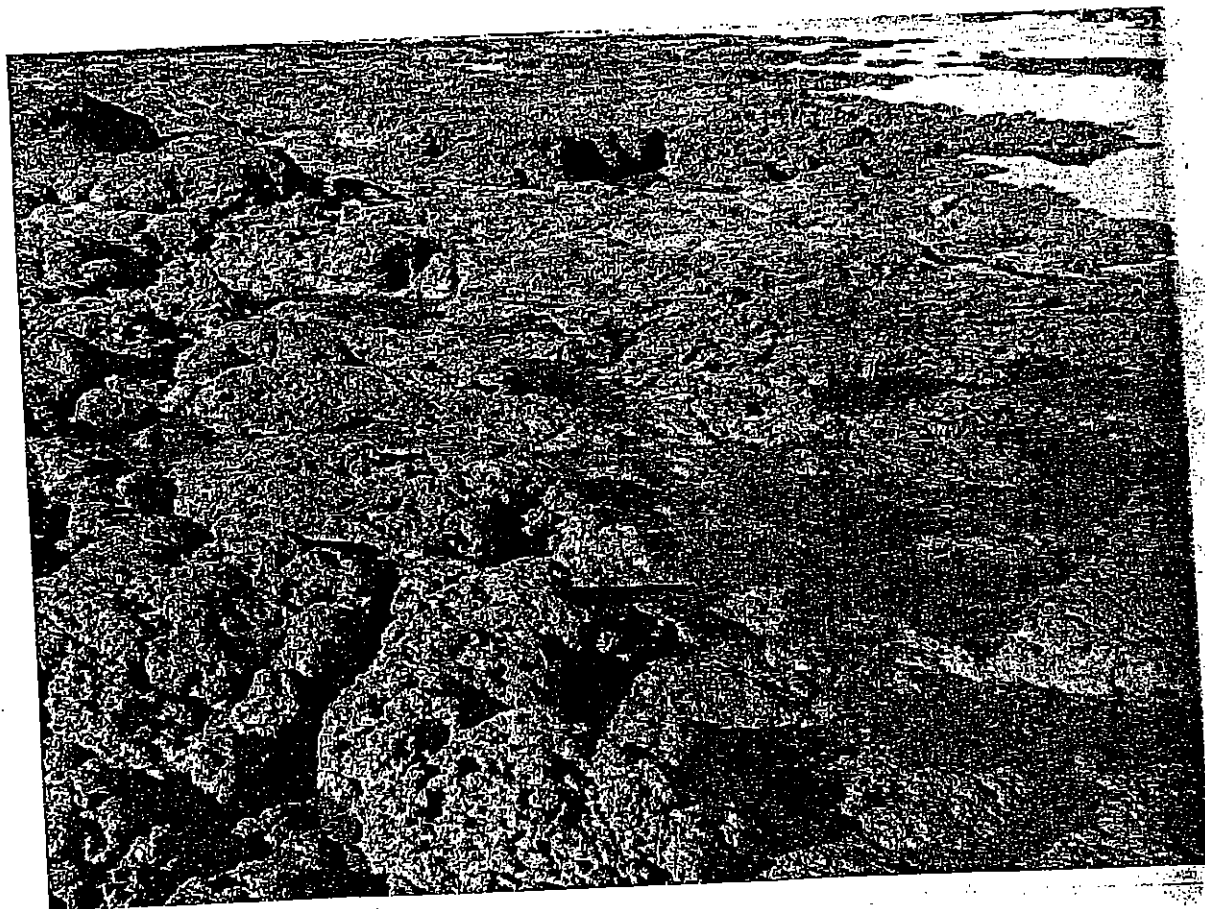
Photo 5. Recently exposed siltstone outcropping within Sub-Area C1.

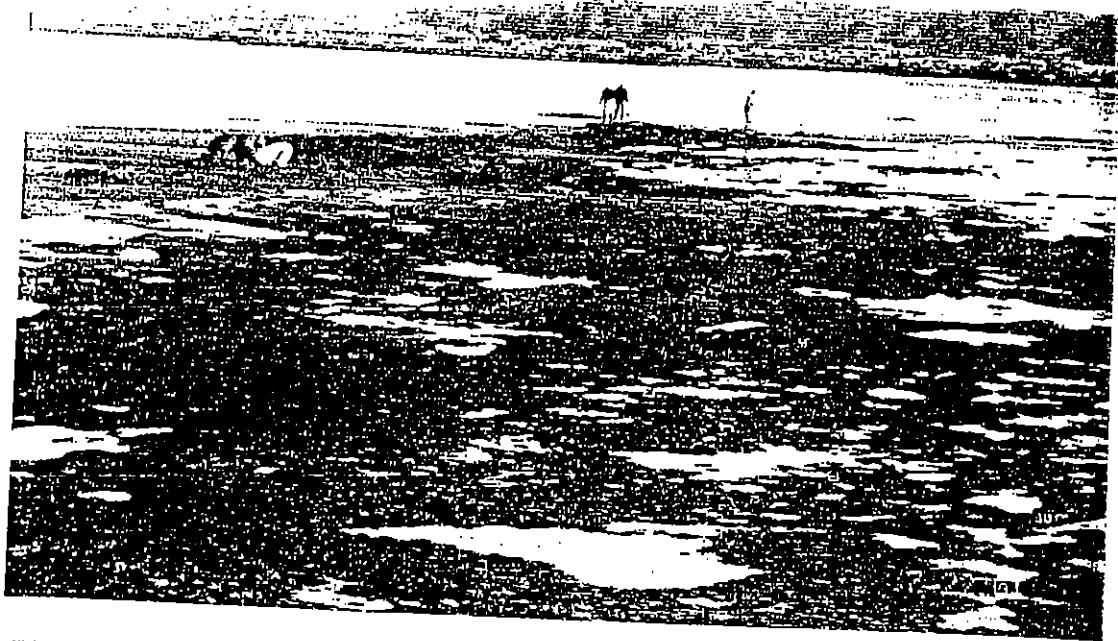
Photo 6. Area C on outside of jetty in July 2001. Clam diggers were digging piddock clams on an area of the siltstone that has been exposed for ten years or more. Most of the siltstone in the foreground was covered with sand until the spring and summer of 2001 (Photo provided by W. Ternyik).

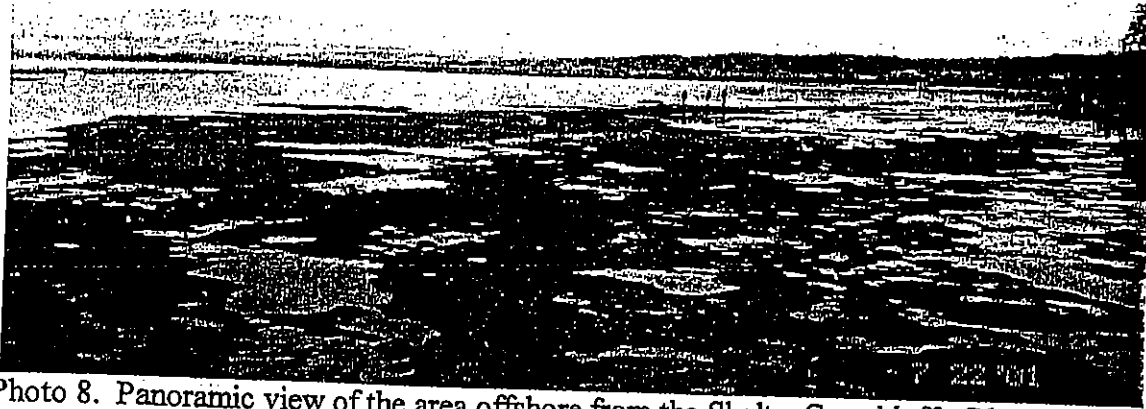
Photo 8. Panoramic view of the area offshore from the Shelter Cove bluffs (Photo provided by W. Ternyik). This entire area was historically a large expanse of exposed siltstone with extensive piddock clam beds.

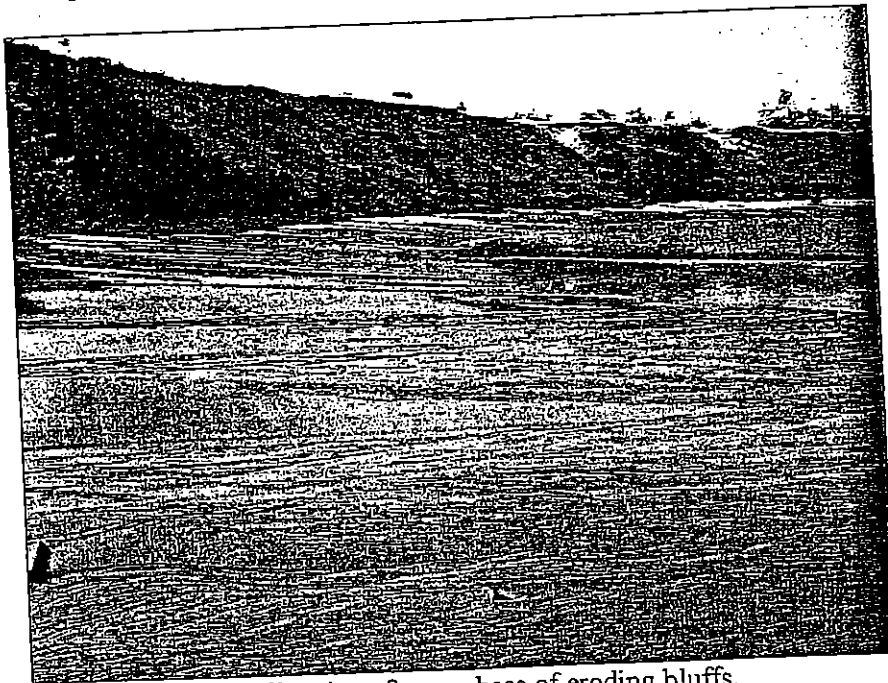
Photograph 6. Sampling Area 3, near base of eroding bluffs.

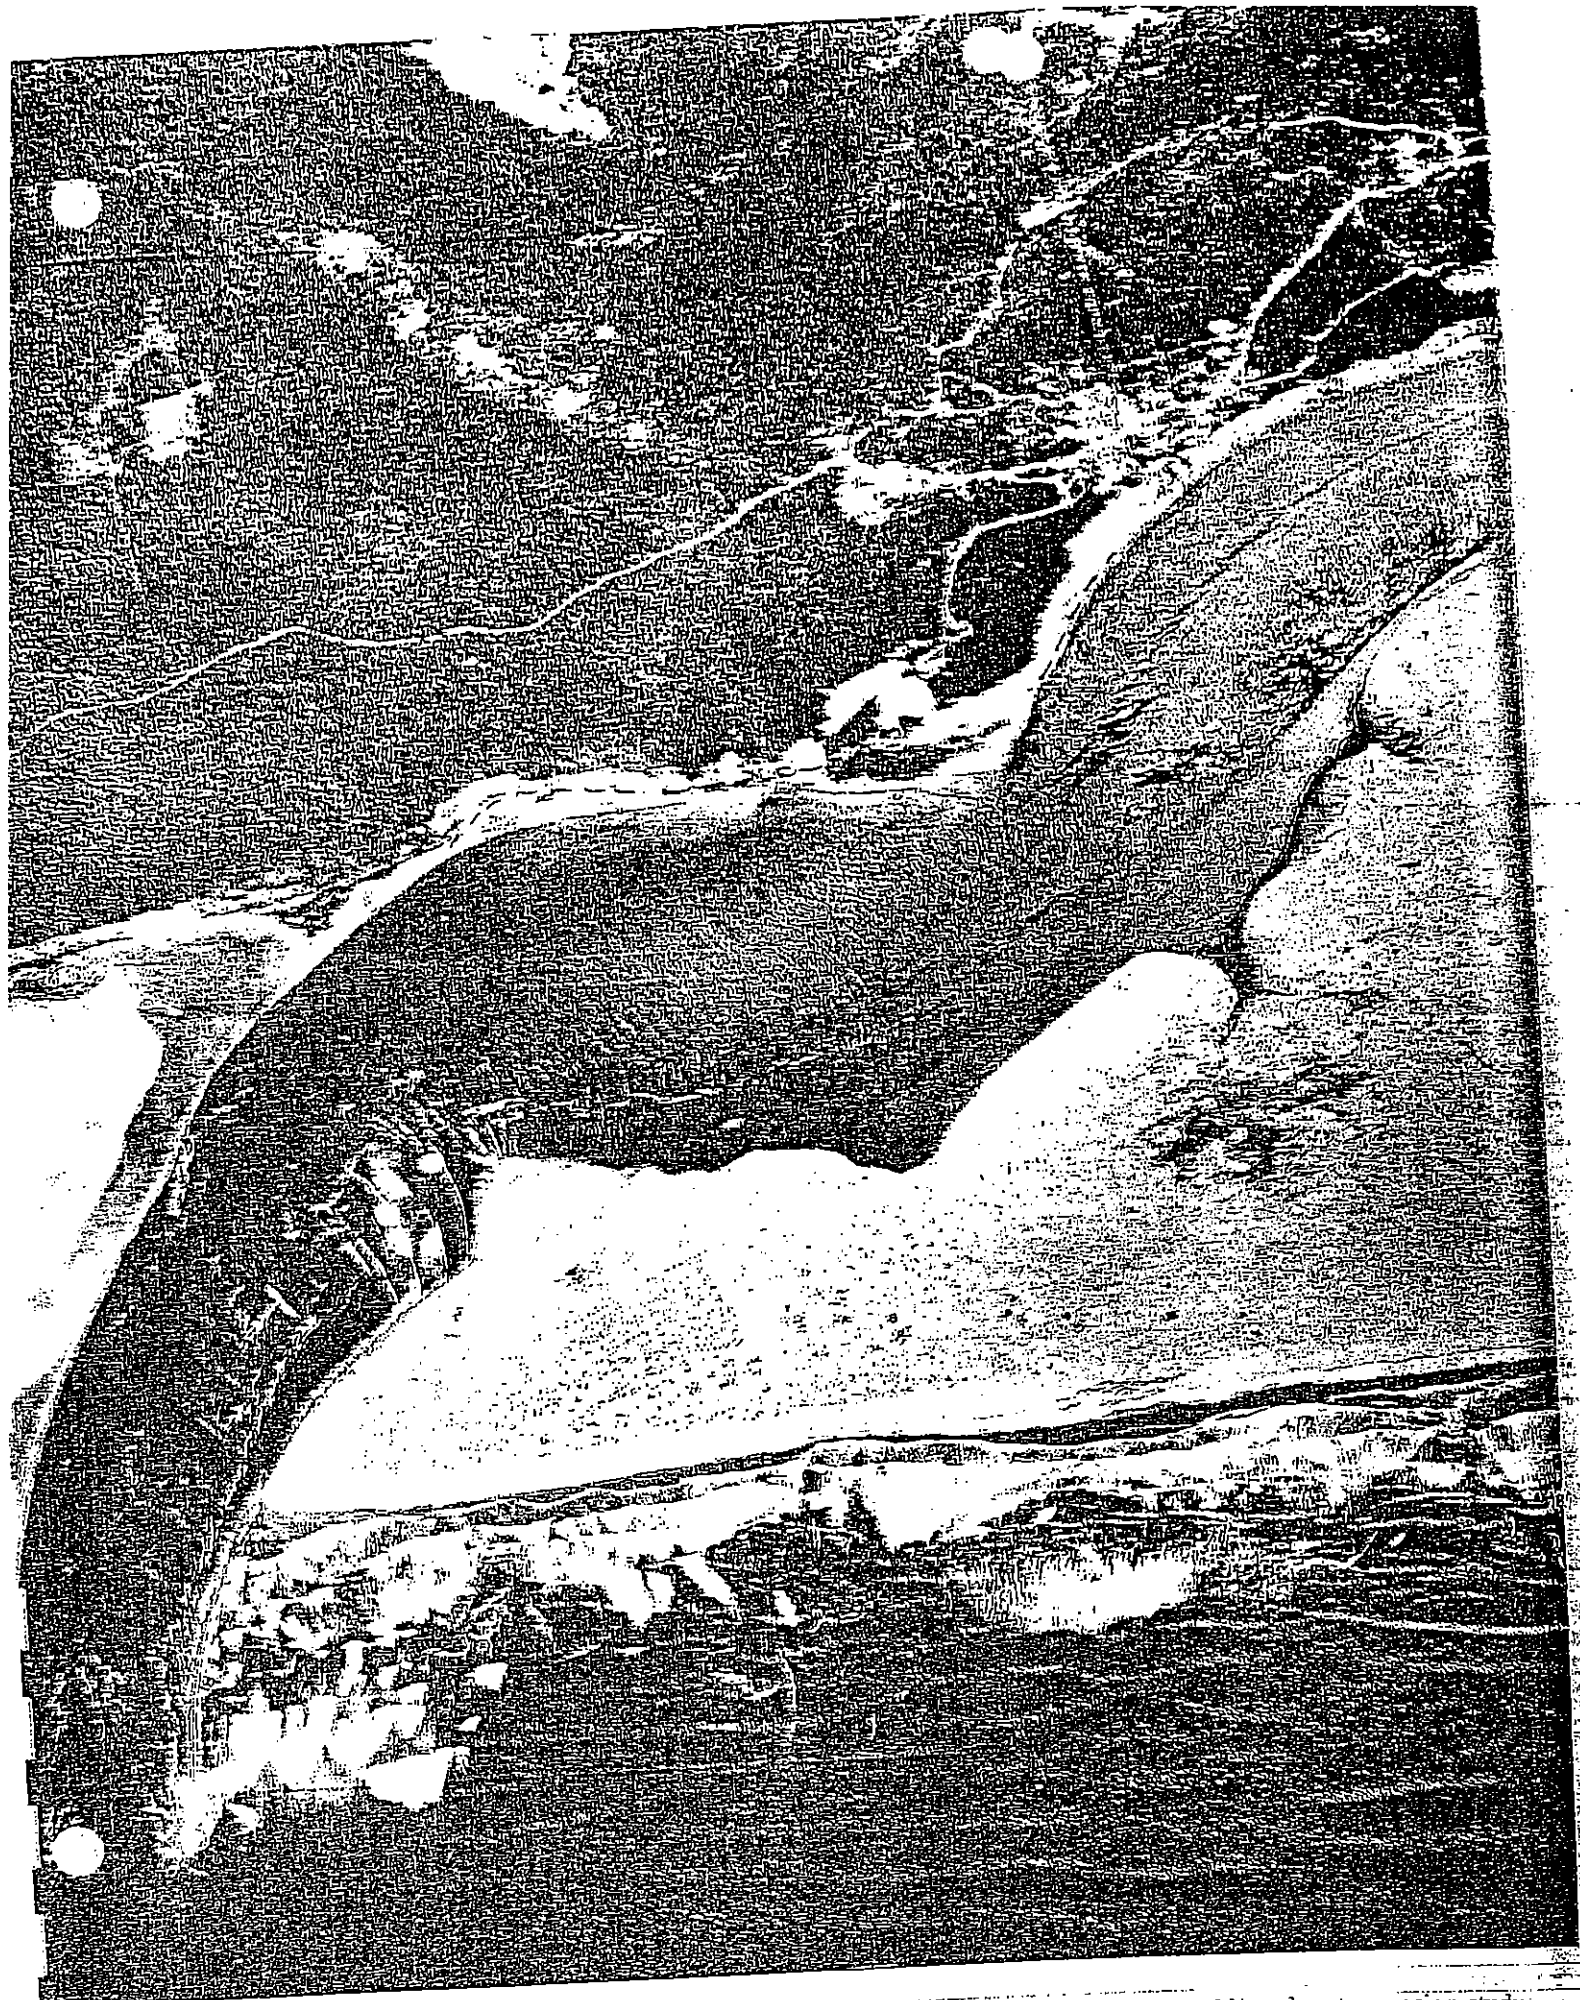
Photo 1 U.S. Army Corps of Engineers photo - Illustrating conditions of the Siuslaw in 1939. Red dotted line denotes erosion study

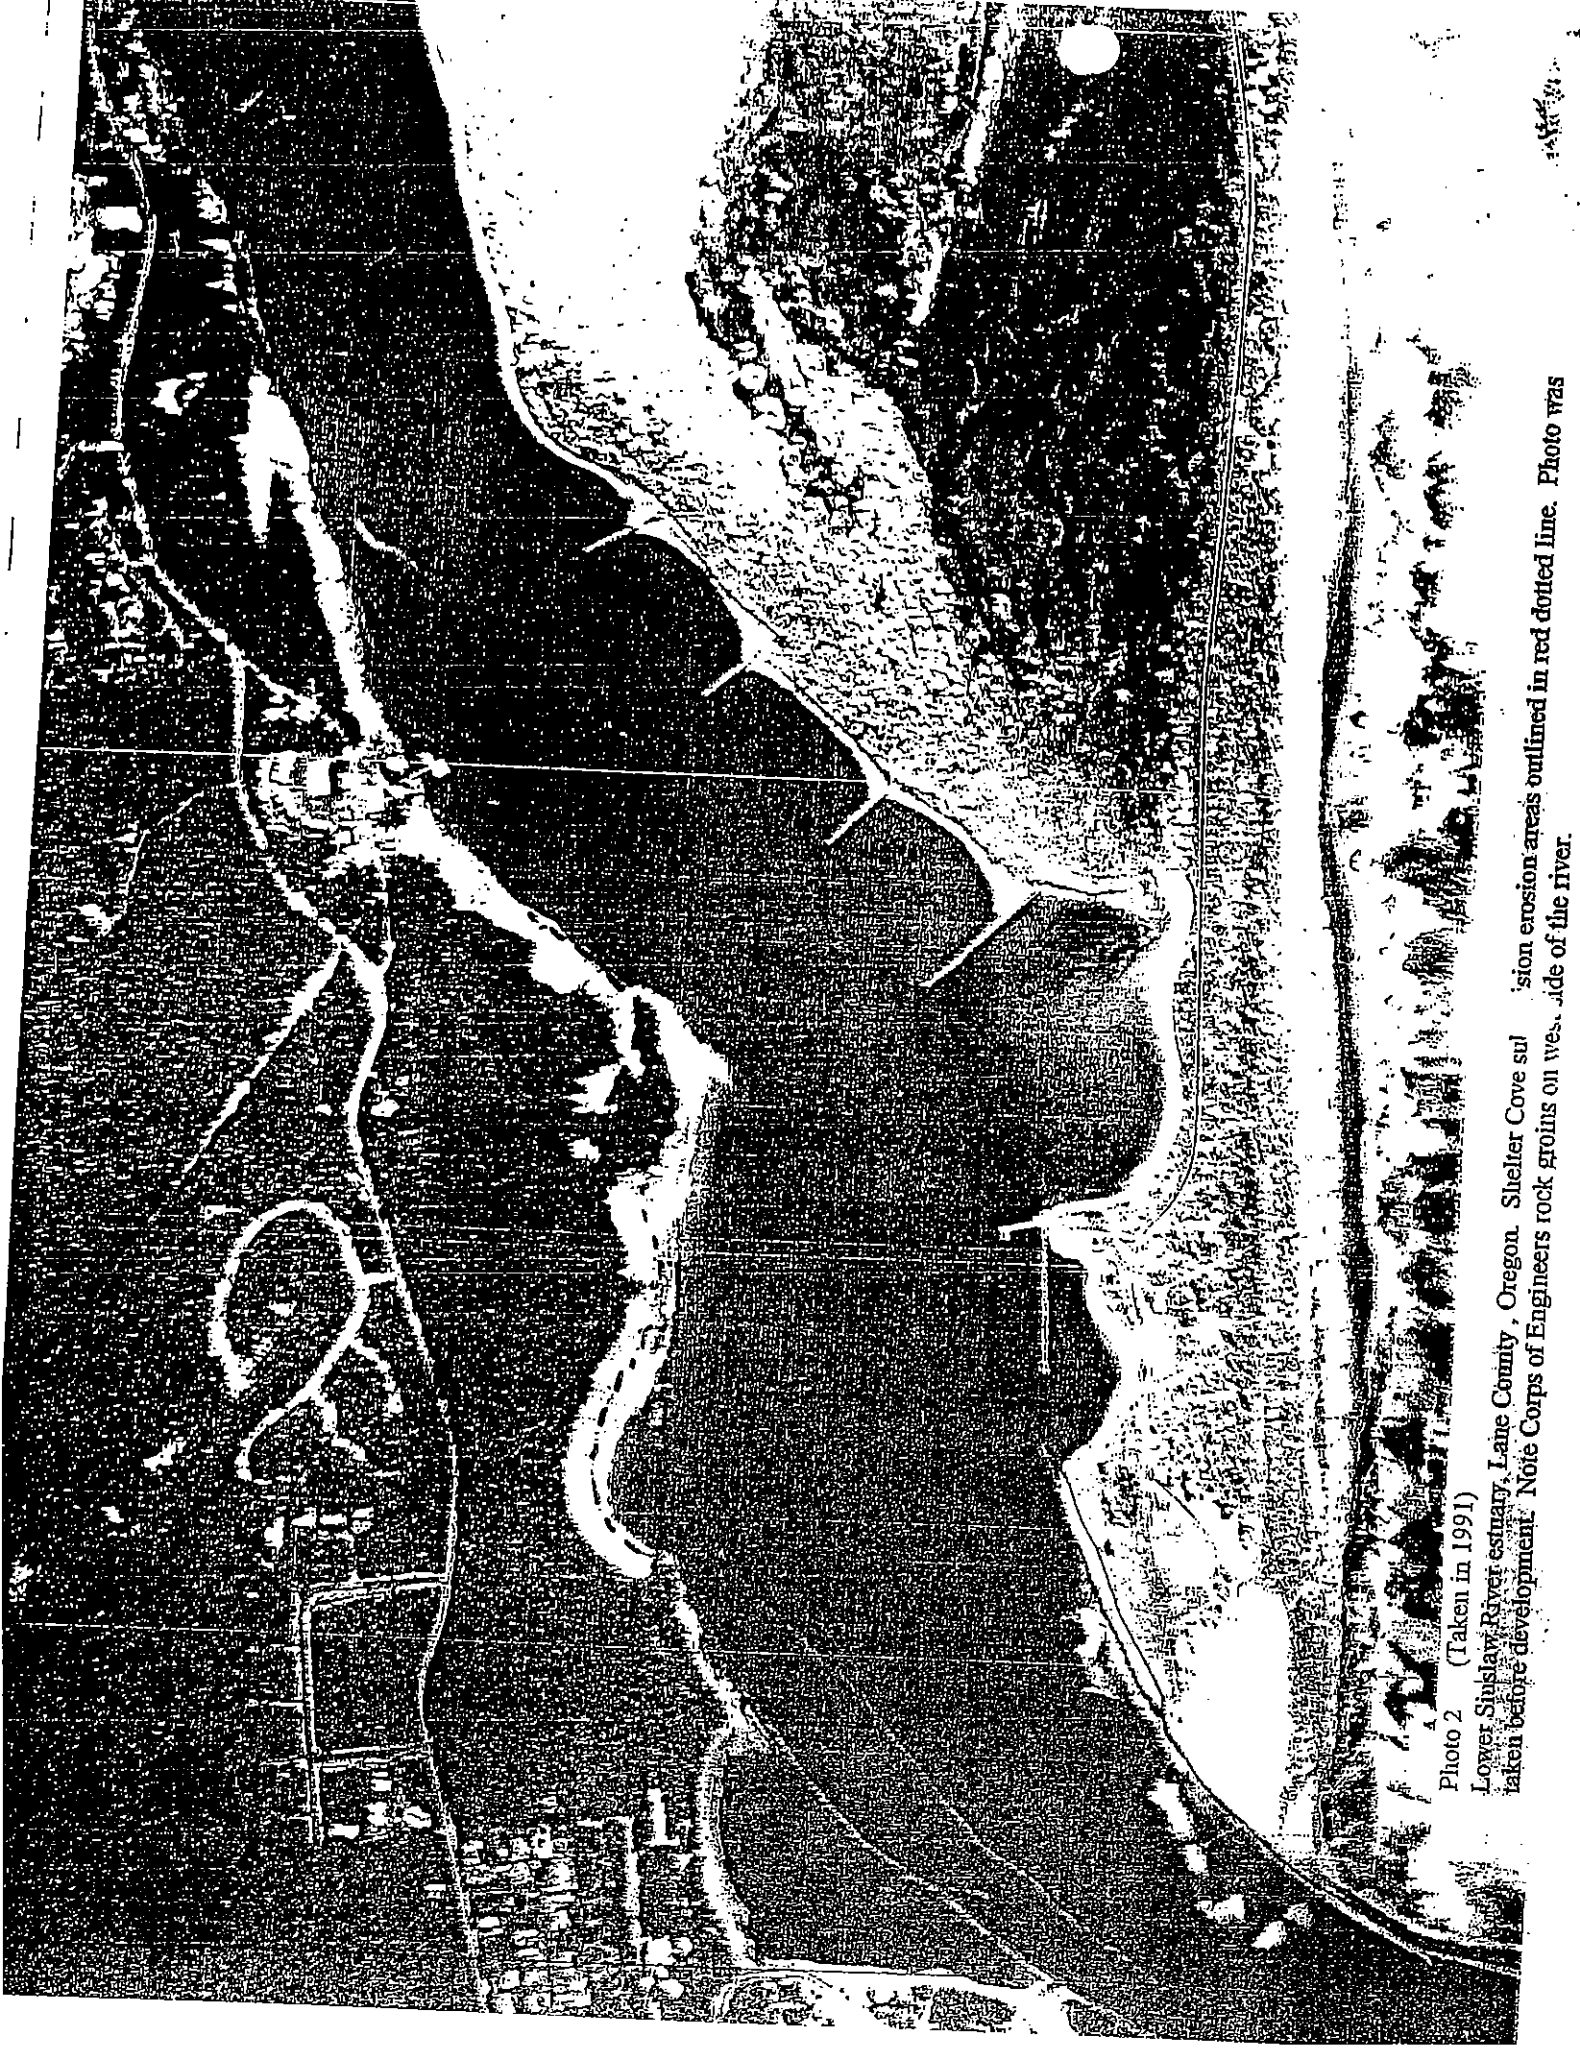
Photo 2 (Taken in 1991)

Lower Siuslaw River estuary, Lane County, Oregon. Shelter Cove sul-
tation erosion areas outlined in red dotted line. Photo was
taken before development. Note Corps of Engineers rock groins on west side of the river.

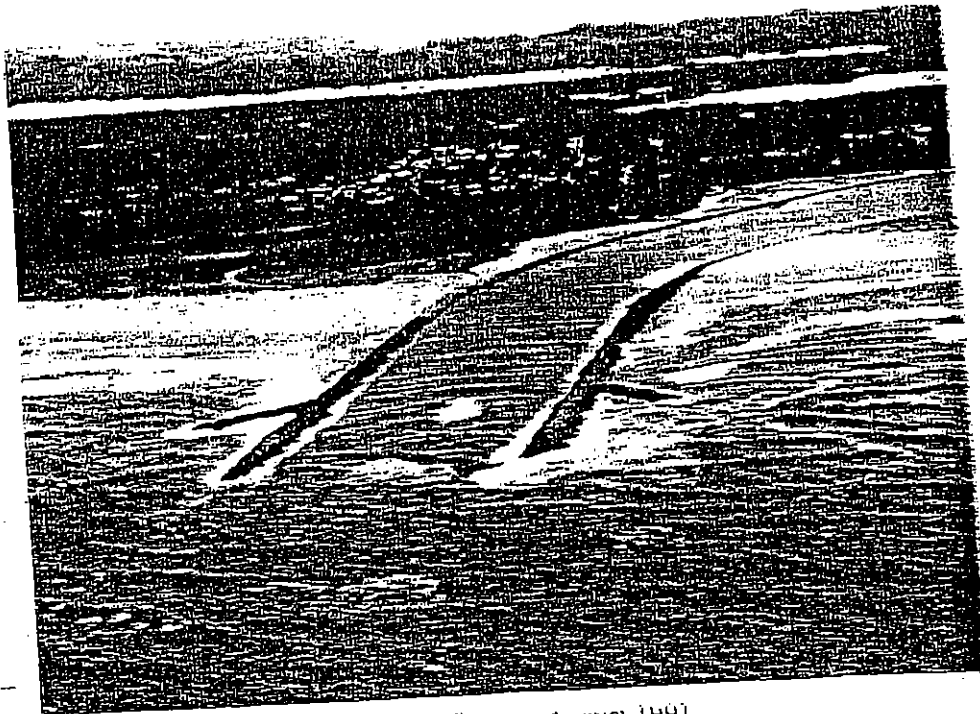
Photo 3 by Wilbur E. Ternyik August 1991

Aerial photo looking east at Siuslaw River entrance to lower bend of river. Entire lower stretch subject to offshore wave surge. Note eroded areas 1 and 2 north of deteriorated north jetty.

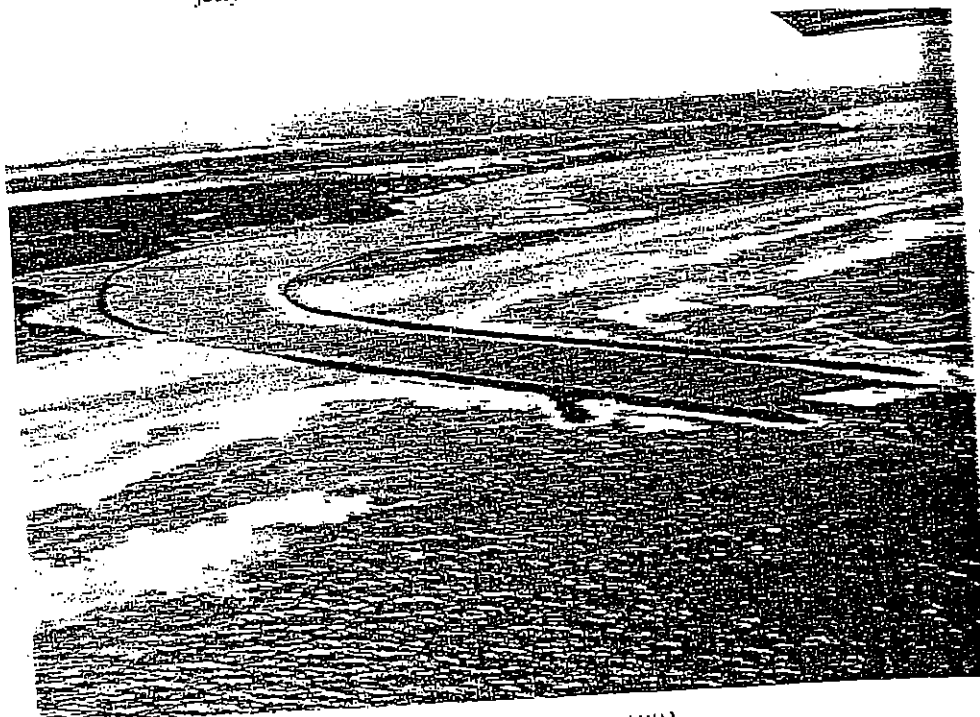
Photo 4 by Wilbur E. Ternyik August 1991

Aerial view looking southeast towards Hurst property erosion site (3). Note Corps of Engineers installed groins (4) on south side of river directing river channel flow to north bank. Erosion site subject to ocean storm wave surge and southwest winter waves over completely deteriorated jetty.

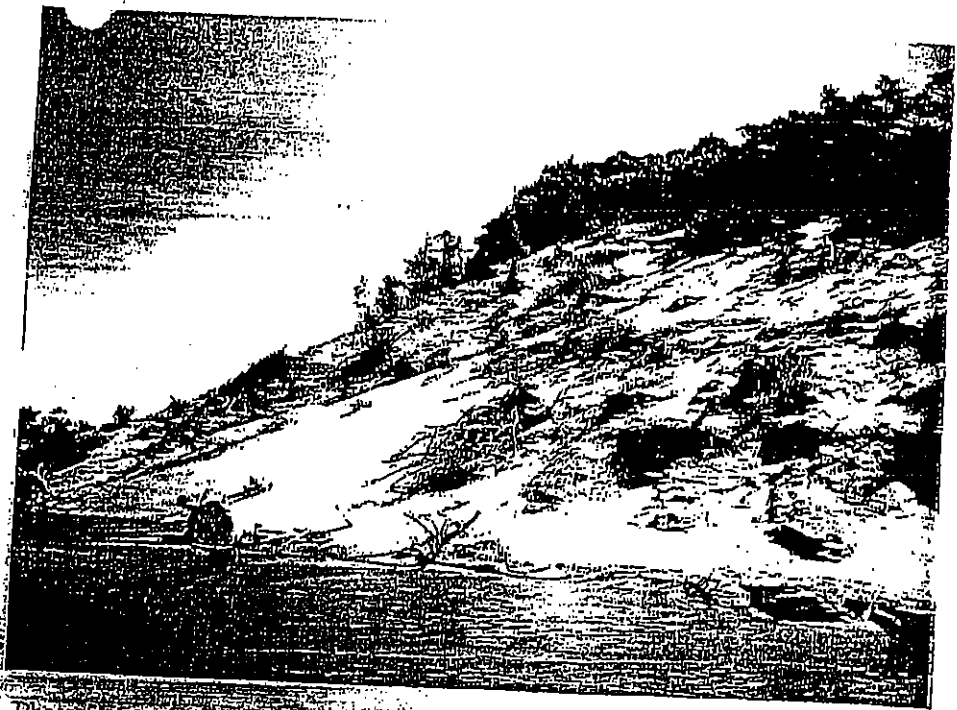
Photo 5 by Wilbur E. Ternyik August 1991

Location: North bank of the Siuslaw River looking east from deteriorated jetty. Note sand bank devoid of vegetation due to wave erosion at the base of the slope and wind erosion on the face. Planned *Ammophila arenaria* planting will stop the bank surface erosion.

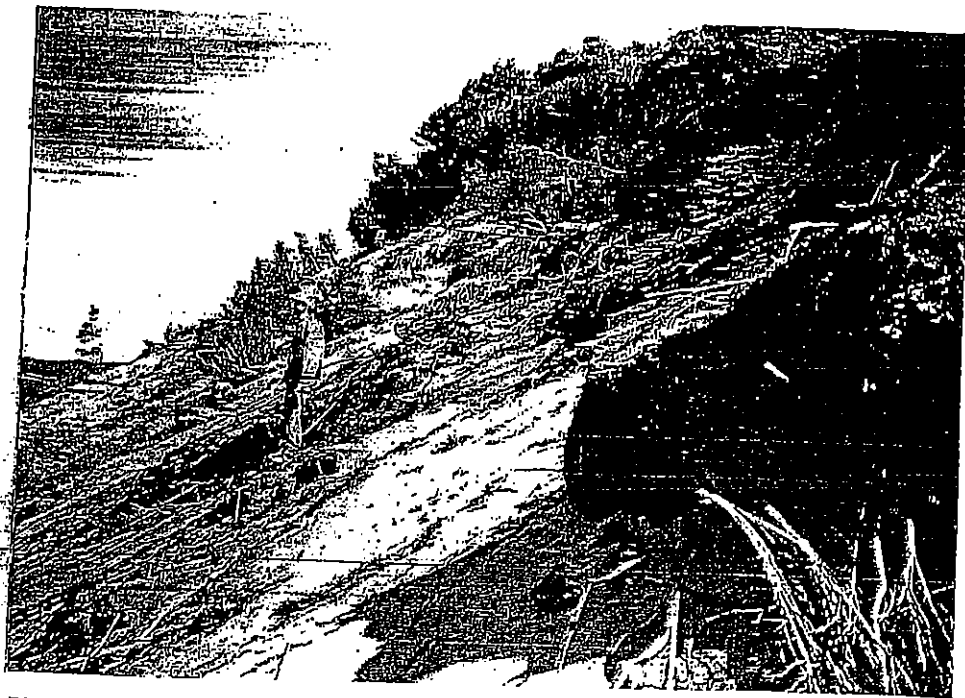
Photo 6 by Wilbur E. Ternyik August 1991

North bank of the Siuslaw River. Illustrating severe wind erosion and sloughing as a result of river erosion at the toe of the slope. Face of erosion slope is currently the Corps of Engineers property.

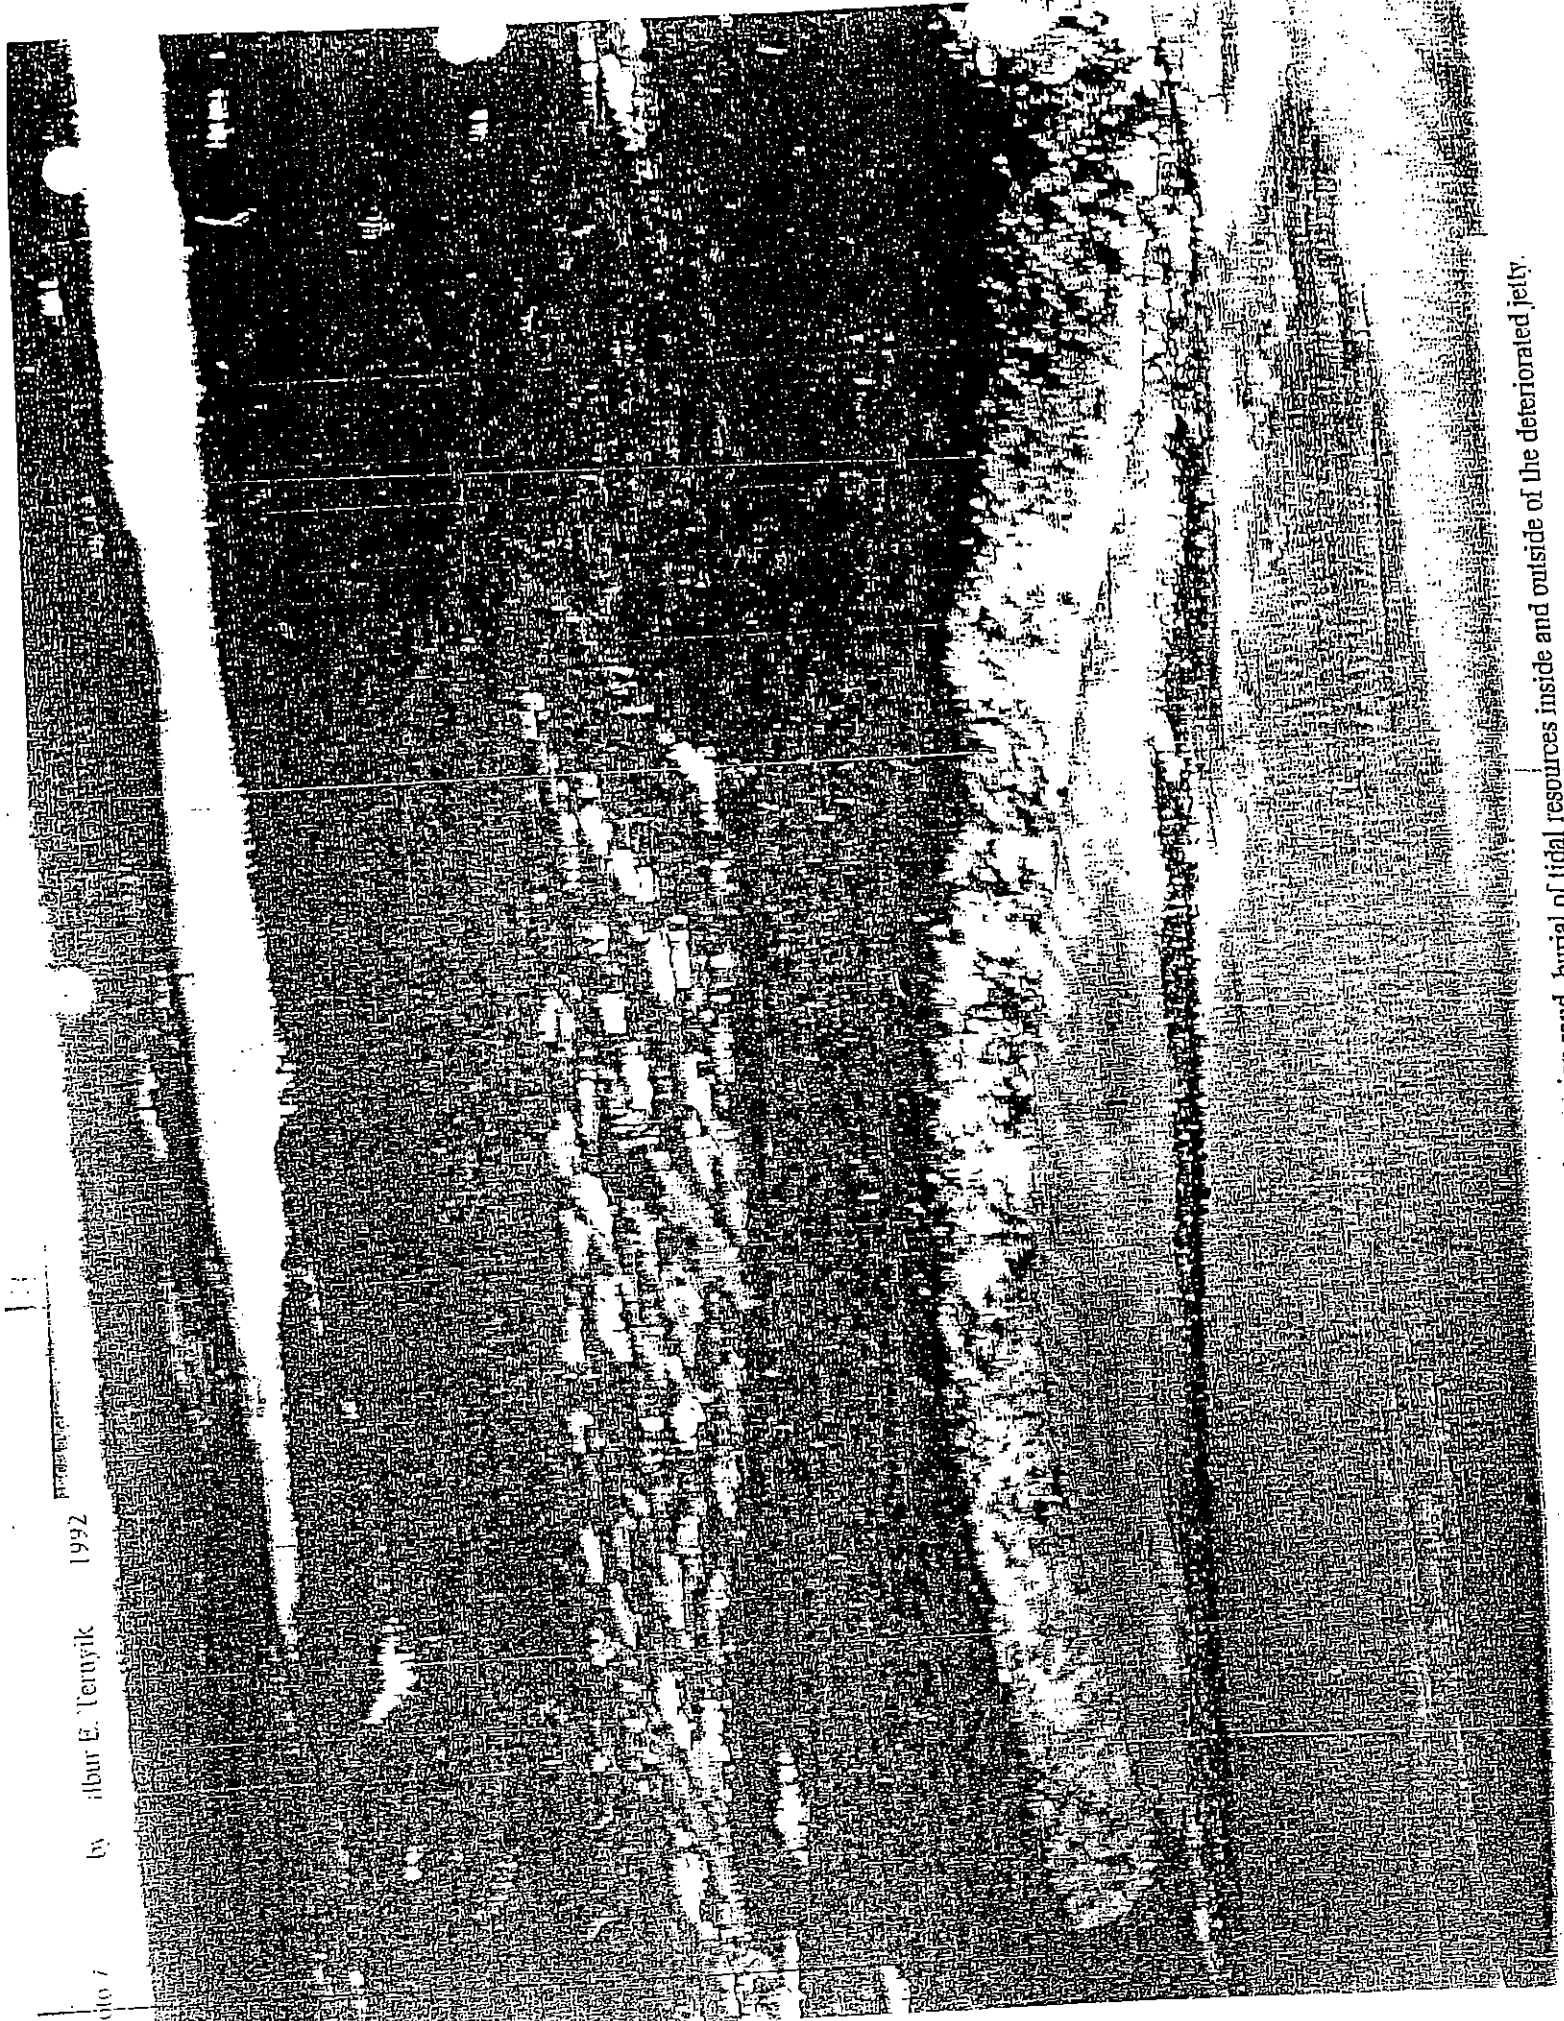
Note massive erosion sand burial of tidal resources inside and outside of the deteriorated jetty.
