SHELTER COVE SUBDIVISION - HISTORIC EROSION REPORT

LOWER SIUSLAW ESTUARY

FLORENCE, OREGON

NOVEMBER 2001

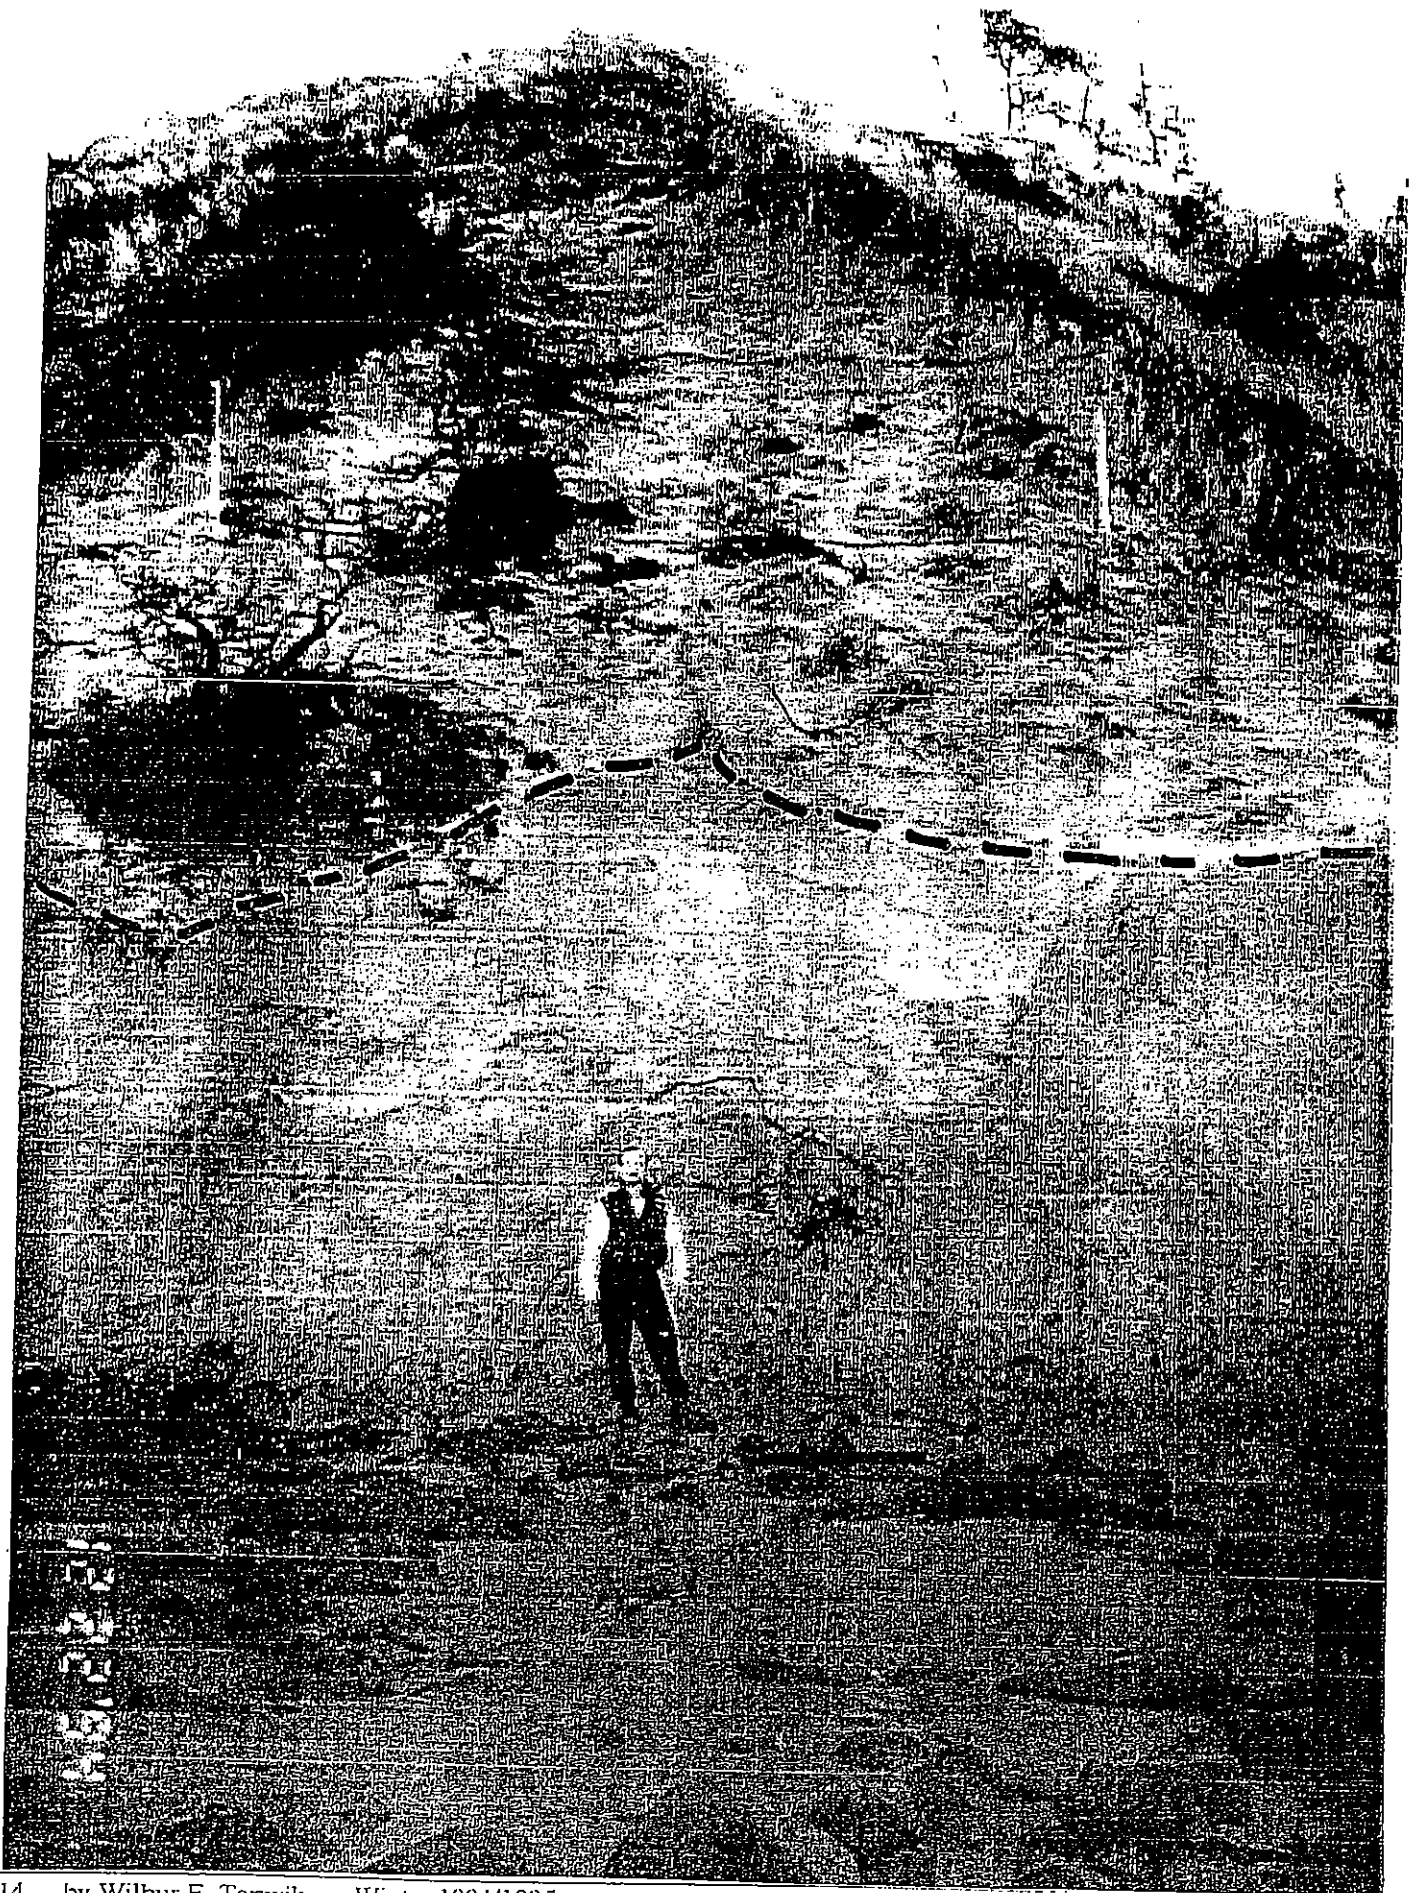
to 14 by Wilbur E. Ternyik Winter 1994/1995
for Cove, looking east at erosion slope fronting Lot 23. Note massive one-year erosion process caused by unprotected toe of the

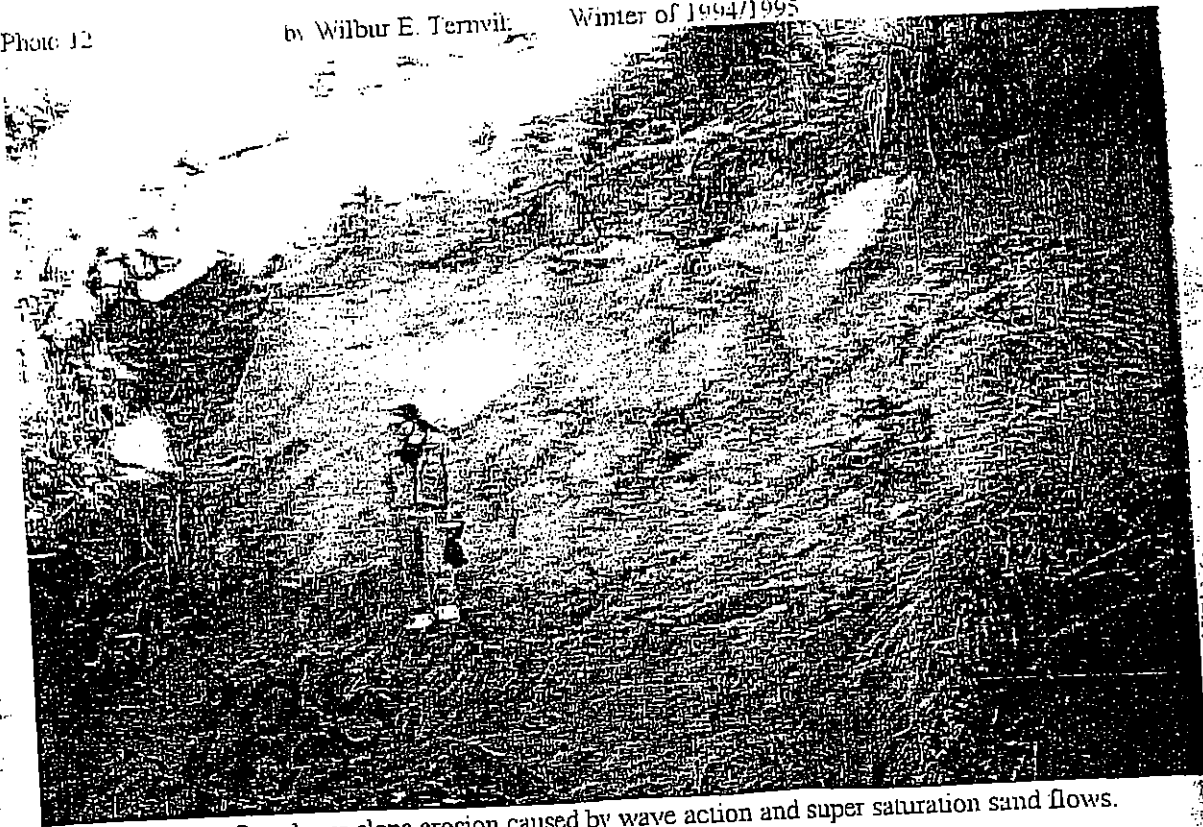
Photo 12

Location: Shelter Cove lower slope erosion caused by wave action and super saturation sand flows.

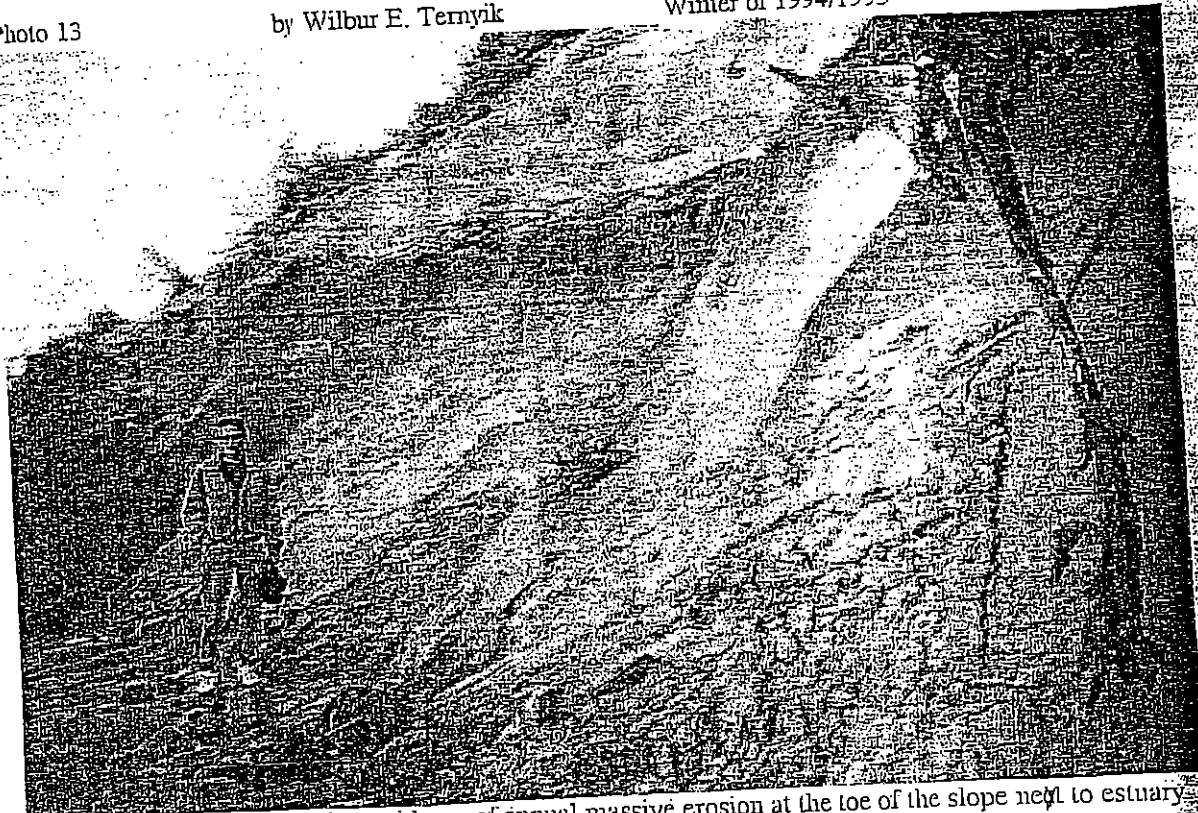
Photo 13

Location: Shelter Cove, further evidence of annual massive erosion at the toe of the slope next to estuary shoreline.

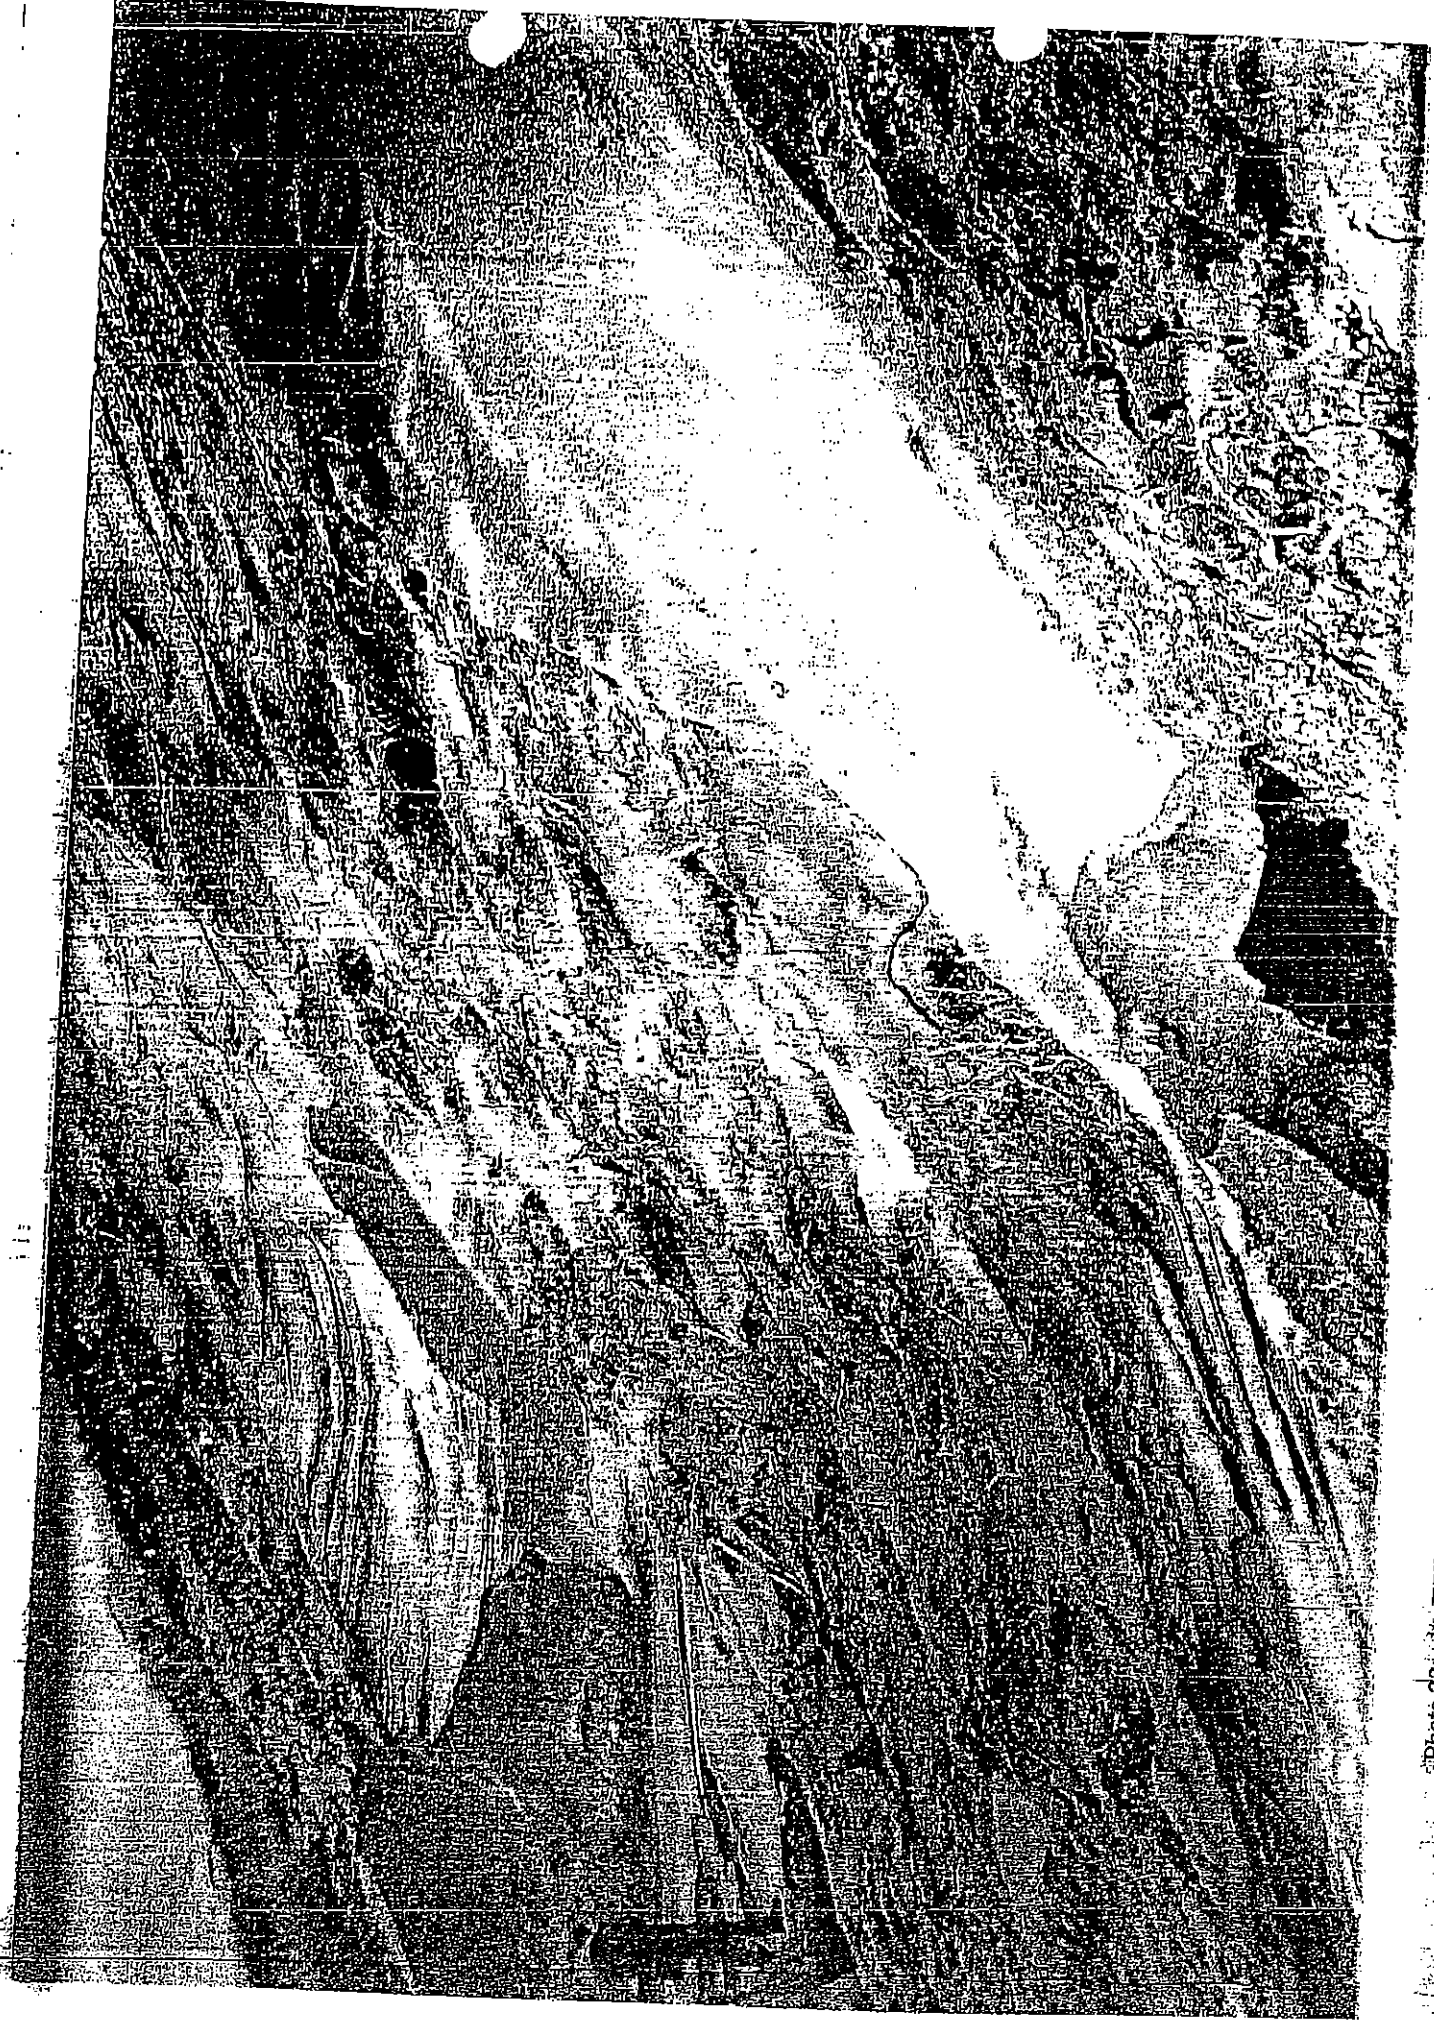
Photo 22 by Wilbur E. Teinyk Winter 1998/1999 Shelter Cove, with Matt Teinyk surveying the massive ongoing sl... ailure. Caused by super saturation and wave erosion of the toe of
