**FIGURE 3: Wetland Delineation Map**

This Wetland Delineation report has been prepared for the McKenzie Community Track and Field Committee (MCTFC) in response to a violation notice from the Oregon Department of State Lands, Enforcement File #6353, which states that fill had been placed on wetlands without a permit. Approximately 12.16 acres (Tax Lot 1300 Tax Map 16-45-29) was donated to the McKenzie Community Track and Field Committee (MCTFC) by Seneca Timber Company in 2004. Beginning in 2003, prior to the donation from Seneca, Seneca allowed the MCTFC to begin clearing vegetation in order to determine the location of the track and associated facilities. The purpose of this study is to document wetland information and map the wetland boundaries within the study area as they were most likely present prior to 2004, based on review of historic aerial photos, field observations, and from interviews with people that have worked on the property. Fill boundaries visible in the 1980, 1981, 1991, 1994 (the last available aerial photo before the 2002 photo) and 2002 aerial photos were compared to the wetland delineation field data in 2006 in order to determine if additional fill had been

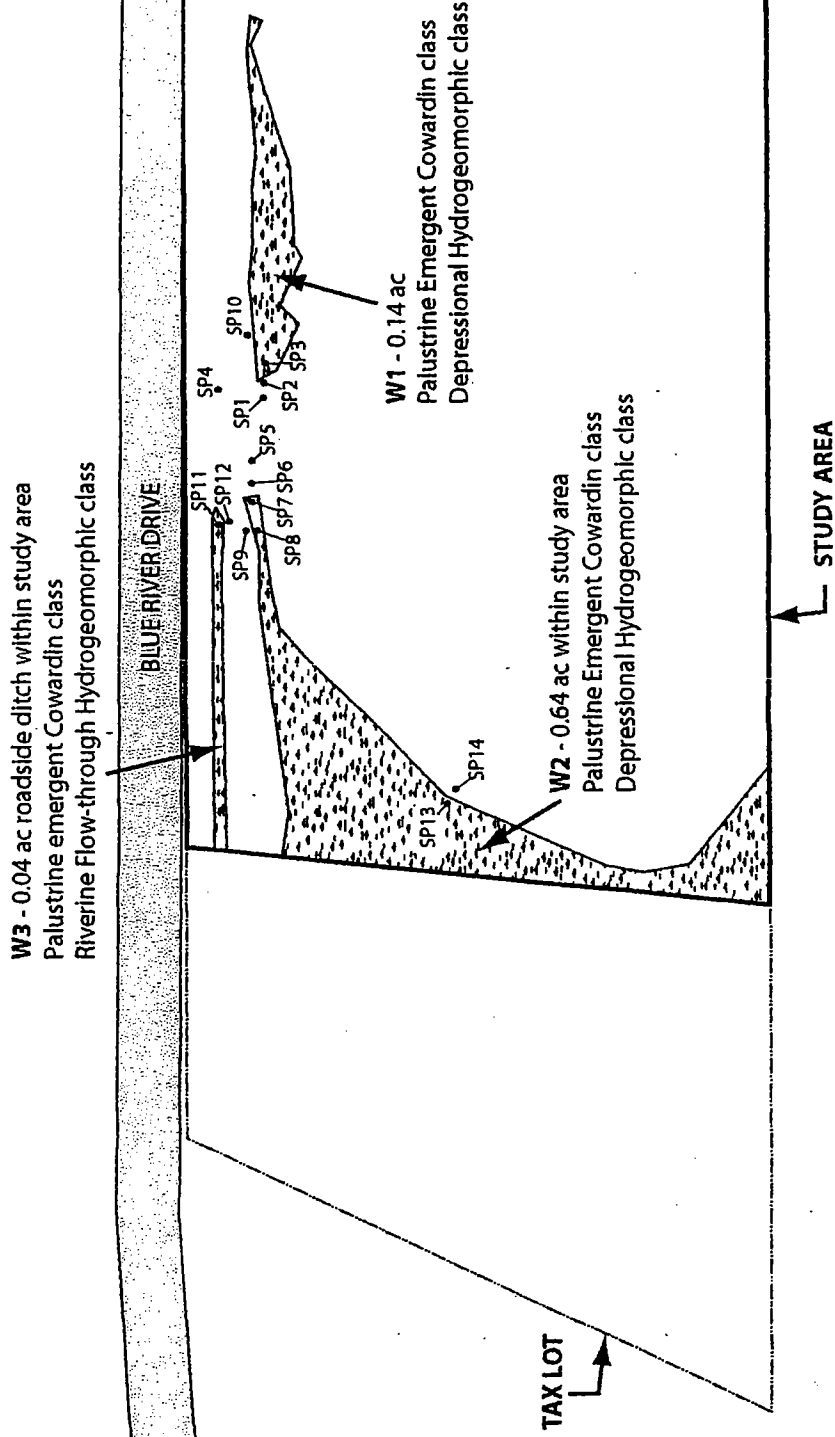
Wetland boundaries and sample points mapped using handheld GPS unit, estimated accuracy  $\pm 10$  feet.

W1: Approximately 0.14 of wetlands in the northeast corner of the study area, supported by SP3. Dominant vegetation is reed canary grass, simple-stem burreed, cattail, false loosestrife, and obtuse spikerush. Soils are a silty clay loam over clay with mottling in the top 10 inches. The wetland

**W2:** Approximately 0.64 acres in the west and northwest portion of the study area associated with the unfilled portion of the abandoned log pond, supported by plots 7, 8, and 13. Dominant vegetation is reed canary grass, with a narrow fringe of Hooker's willow, and Oregon ash and cottonwood saplings along the east edge of the log pond where it abuts the old fill. Soils in this wetland area were observed to be a silt or silt loam to at least 18 inches, with a chroma of two and mottling in the top 10 inches. Oxidized rhizospheres were also observed in the sample plots within this wetland area. The wetland boundary was determined to be along the old dike or old fill, at the elevation where Armenian blackberry was rooted and hydric soil indicators were no longer observed. This wetland is in the PEM Cowardin class and the Depressional HGM class with its primary sources of hydrology from precipitation and surface runoff. This wetland continues off the study area and is enclosed by the old dike for the log pond, except where it was breached and a beaver dam constructed across the breach in the southwest corner of the Tax Lot (outside of the study area).

**W3:** Approximately 0.04 acres of shallow roadside ditch in the study area, north of the log pond dike and south of Blue River Drive. It is supported by SP 11. The ditch is 6-8 feet wide across the channel bottom, with a 20-25 foot top-of-bank width. The wetland boundary and ordinary high water (OHW) elevation were determined to be one and the same, and located approximately 1 foot higher than the channel bottom, where a dominance of hairy willowherb changes to a dominance of Armenian blackberry, and at the uppermost level of erosion observed near SP 11. Soils were observed to be a gravelly silty clay loam, indicative of the old fill, with mottling at 8-12 inches. Based on the observations, the ditch appears to carry water infrequently, as most of it is covered with Armenian blackberry, both along the banks and across the bottom. The ditch begins as a recognizable feature near SP 11, and continues offsite to the west. This ditch is in PEM Cowardin class and the Riverine Flow-through HGM class with its primary hydrology source from surface runoff.

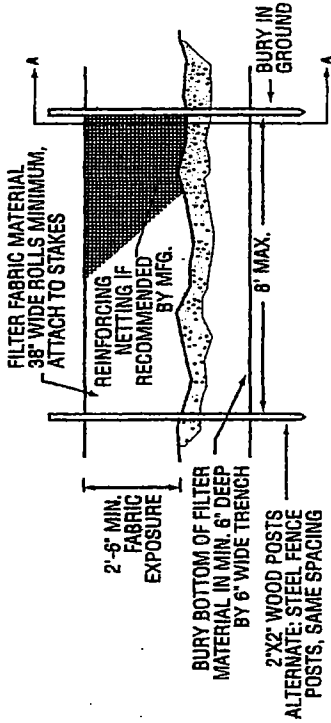
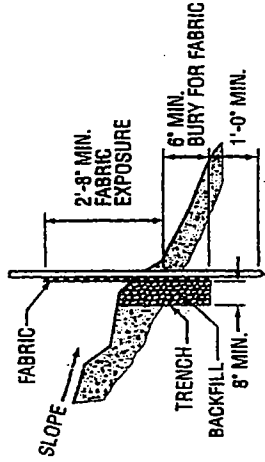
**TYPICAL SEDIMENT FENCE DETAIL**

- NOTES:**
1. Installation shall follow the manufacturer's recommendations.
  2. Posts shall be installed so that a min. of 3'-0" extends above the ground with a min. 2'-0" embedment.
  3. Filter fabric fabric shall be purchased in a continuous roll to avoid joints.
  4. Splice joints at support posts only, with a min. 6" overlap.

**ELEVATION**

**SECTION A-A**

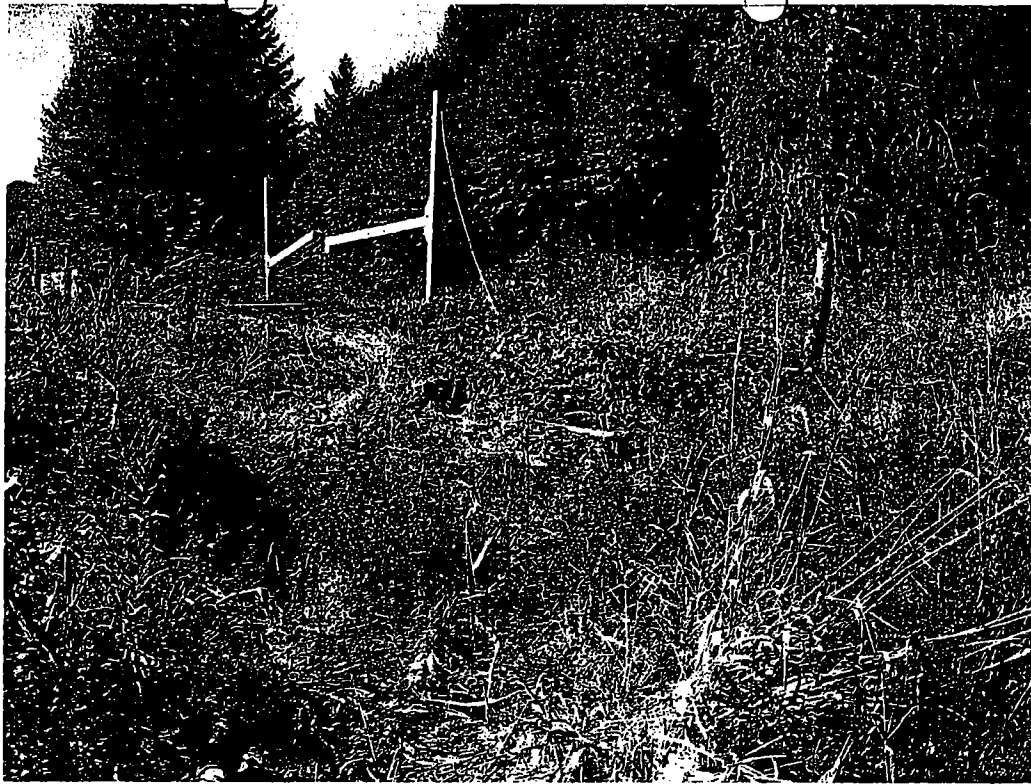
P5 looking west from near SP3 (foreground orange flag) to road crossing with new culvert and 6-inch lift of gravel on top of the old road crossing. Culvert was installed in bottom of old ditch excavated across the road crossing by Seneca prior to 2002, to prevent access onto the site. Culvert bottom is 1-1.5 feet higher than the wetland boundary. Wetland boundary for the unfilled portion of the log pond east of the old road crossing is approximately 15 feet east of the culvert, and indicated with the pink flag in the middle of the photo.

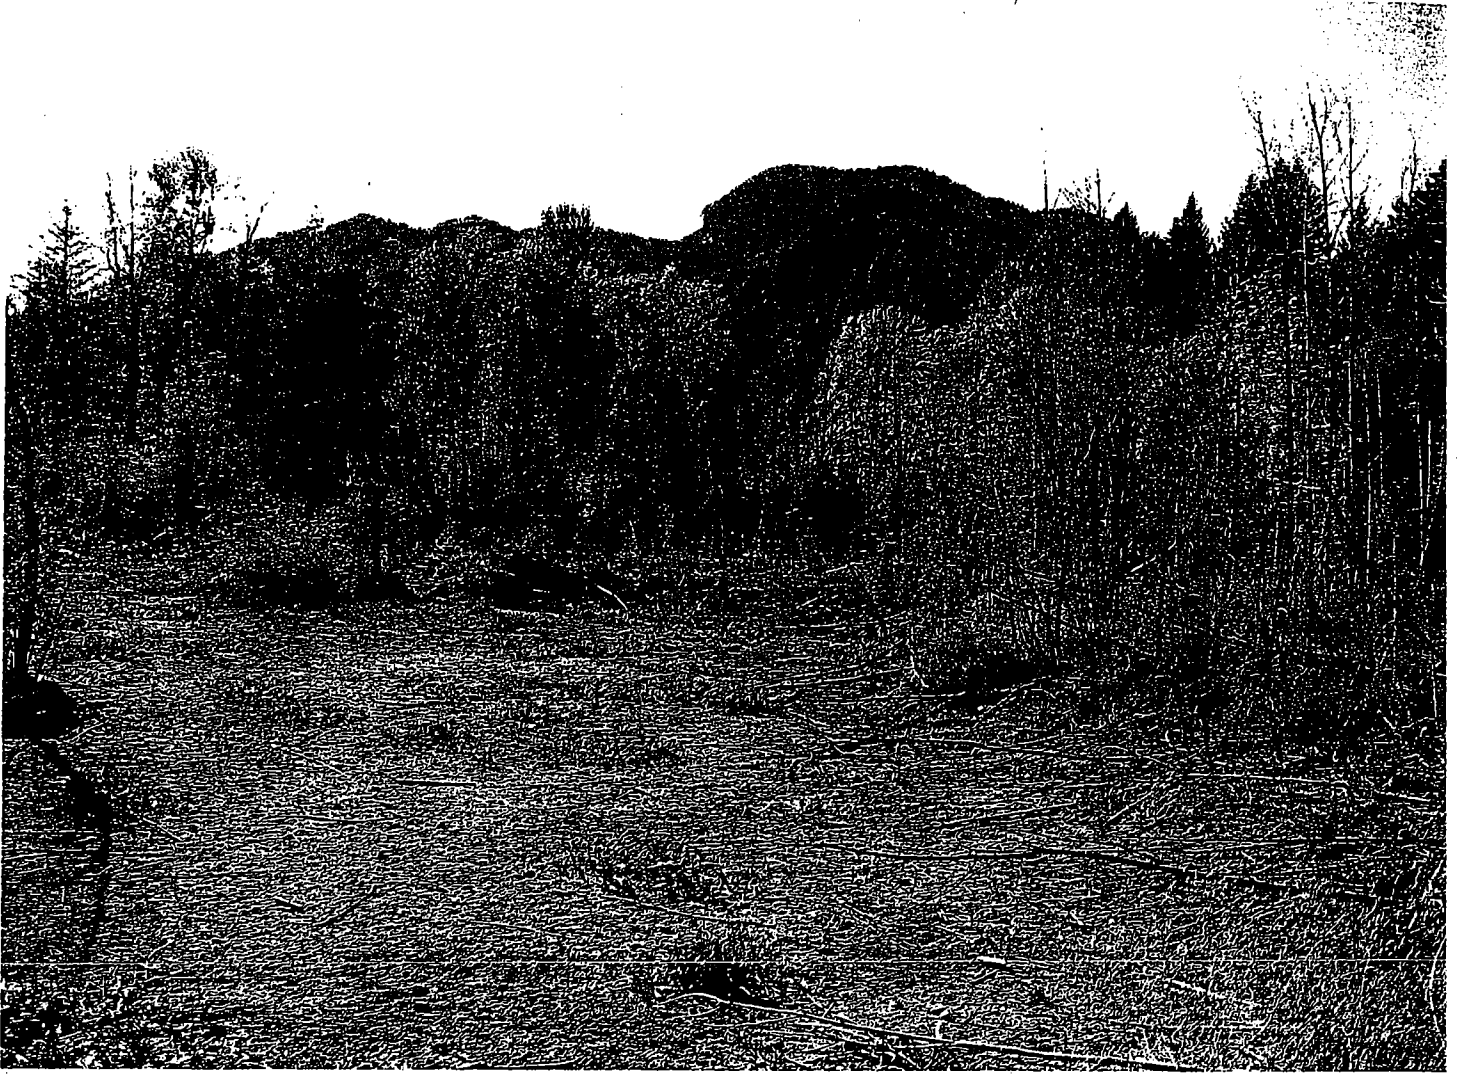
**P7 looking west from old fill near SP 14, across unfilled portion of log pond in west portion of site and study area. Majority of vegetation cover is reed canary grass, and the pond is typically 2-3 feet deep winter through spring. Old dike is barely visible in high middleground.**
